COMPREHENSIVE ENERGY AUDIT

SELAWIK WATER TREATMENT PLANT AND SANITATION SYSTEM

Selawik, Alaska

March 7, 2011

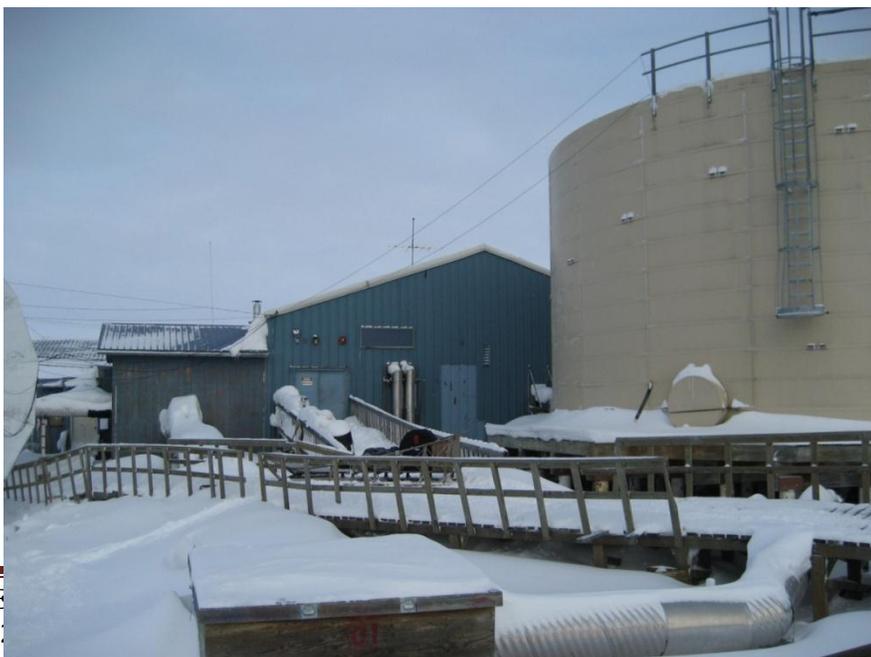
3.2 Water Treatment Plant

The water treatment plant is a 5,700 square foot steel frame building. It is mounted on steel piles and has three inches of foam insulation covered with metal siding and a corrugated metal roof. Floor insulation is minimal and may actually be resulting in snow melting under the building.

The building was originally built in 1973 and has been upgraded and added onto since then with the most recent being in 1995. Overall it is in good condition although the limited amount of insulation is far below standard for a building in the arctic.

The blower door test results on this building clearly indicate it can and should be sealed tighter. This was especially true of all of the doors.

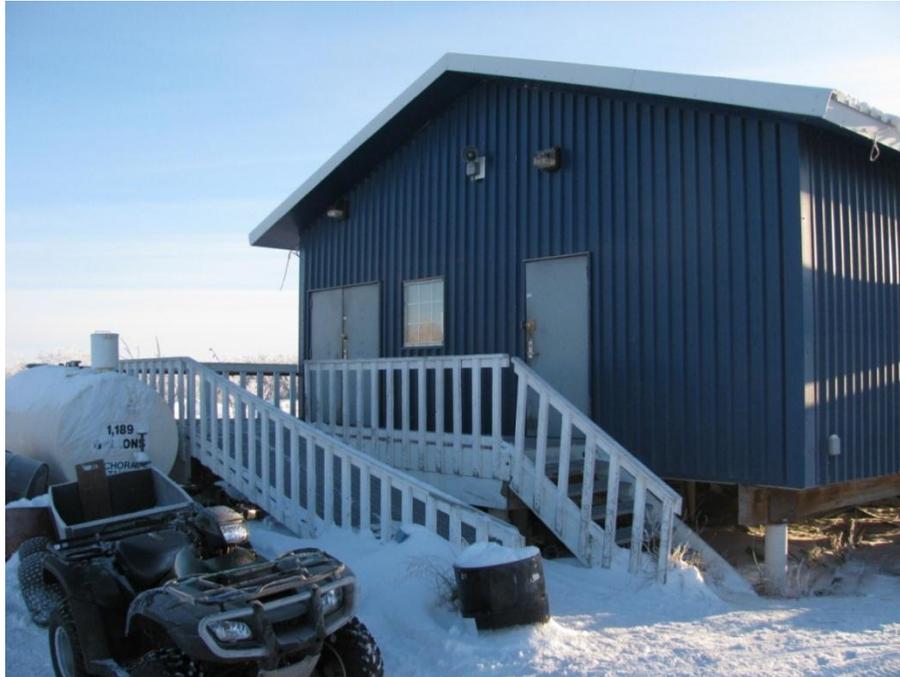
3.3. Island Vacuum Plant

The island vacuum plant is a 1,120 square foot steel frame building. It is mounted on steel piles and has three inches of foam insulation covered with metal siding and a corrugated metal roof. Floor insulation is minimal.

The building was built in approximately 2000 and overall is in good condition. However, the limited amount of insulation is far below standard for a building in the arctic.

The blower door test on this facility helped us identify several leaks that need to be eliminated. They are the exhaust dampers for the emergency generator are not closing properly, the dampers on the fresh air inlet for the emergency generator are not closing properly, the double doors on the front of the building do not latch between doors which results in a significant air leak, the draft damper on # 2 boiler is missing.

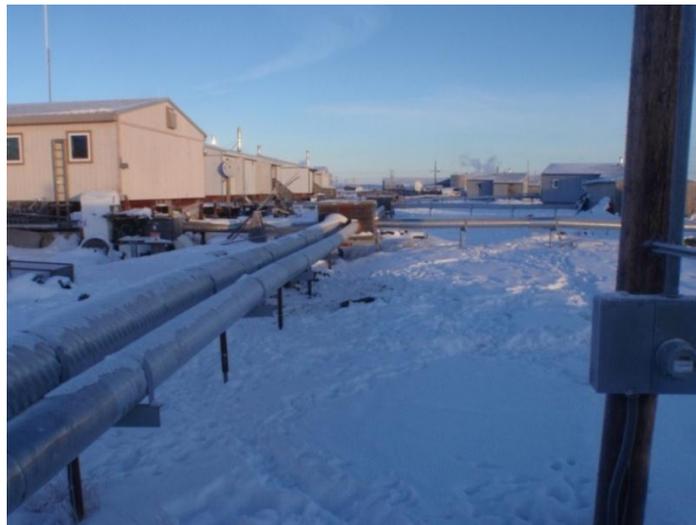
3.4 Water Distribution Loops

The vast majority of the water loops circulated from the water treatment plant are separate from the sanitation lines and run in arctic pipe. The design intent was that the heat-add on the recirculation heat exchanger would keep the water in these lines from freezing. The heat tape was meant to be used in an emergency only.

The water lines in the island are run in a utilidor that also includes the vacuum sanitation piping.

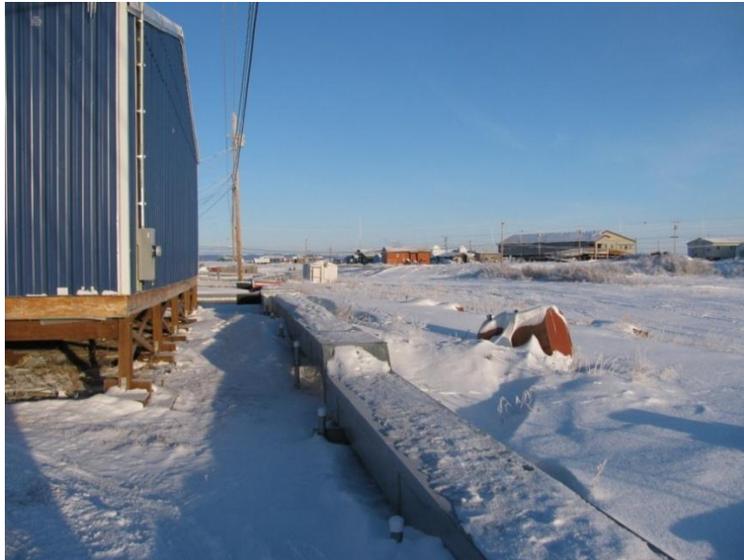
3.5 Vacuum Sanitation Lines

All of the vacuum sanitation lines to the water treatment plant are also run in arctic pipe. As noted above, the vacuum lines on the island are run in a utilidor that includes both the water and sanitation lines.

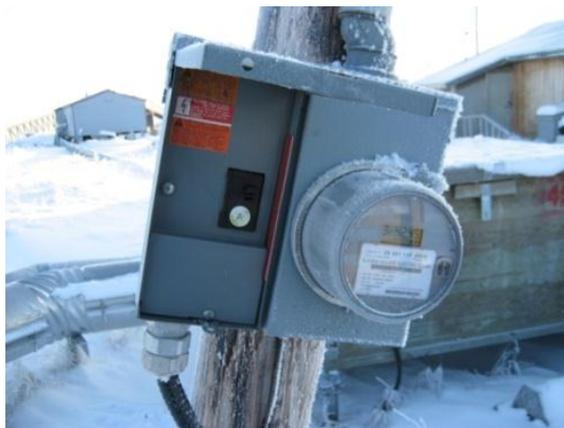
Add Controls to Pump House Heat Tape

The heat tape that is used to keep the pump house above freezing so the raw water can be pumped from the river to the water treatment plant is just a large coil of heat tape in the bottom of the pump house with no controls on it. During the audit the pump house was approximately 80 degrees when the outside temperature was zero. The existing glycol heater and back-up electrical heater should be repaired, put back into operation, and the heat tape removed.

The simple payback would be the cost divided by the savings or $\$2,500/\$2,684 = 0.9$ Years.

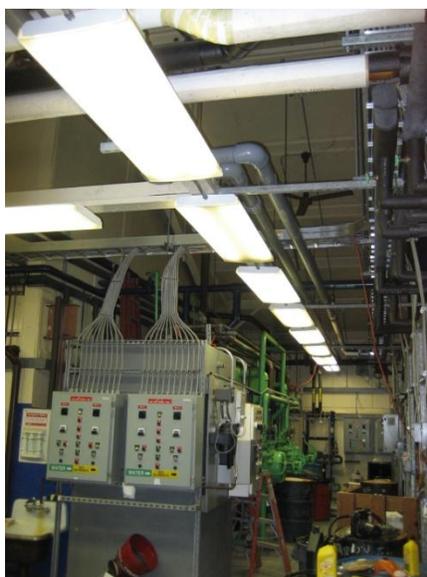
Re-commission the Vacuum Pumps

During the on-site visits, it became obvious that the vacuum pumps in both facilities are not operating per the original recommendations of the manufacturer. Both the pump staging (lead/lag) settings between the primary and secondary pumps as well as the absolute on and off set points should be adjusted to reduce run times. This should be done with the input of the manufacturer. The manufacturer also recommends an alarm be added on each set of pumps to alert operators of excessive run times.

Discussions with the manufacturer have indicated that the run times are excessive and that some of that is due to attempting to reach higher than necessary vacuum levels and improper on/off settings between the lead and lag pumps. The pump load is linear in the vacuum level range we are operating so any decrease in the set point will result in savings. The addition of an alarm on each set of pumps will alert the operators to excessive run times due to leaks. In discussions with the manufacturer, he stated that a 10% savings in power consumption would be a very conservative estimate of what we should expect from a combination of the addition of the alarm and re-commissioning the pump controls.

The simple payback would be the cost divided by the savings or $\$5,500/\$4,499 = 1.2$ Years

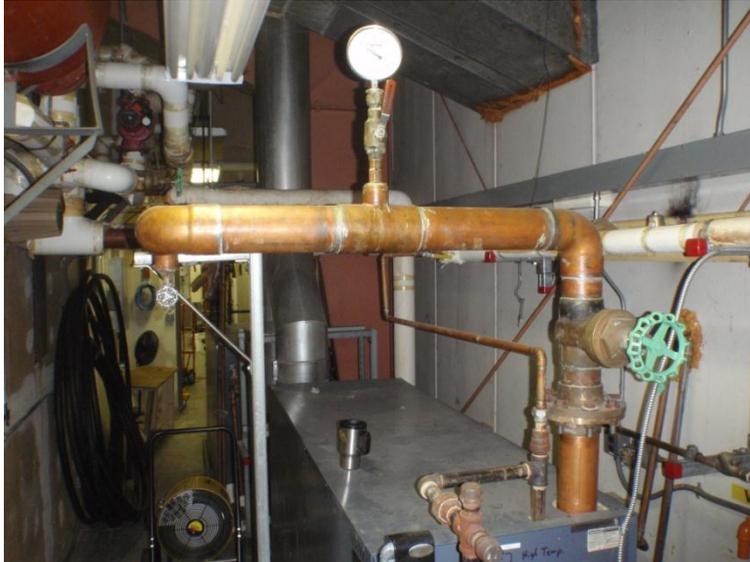
Reduce the Building Shell Leaks in the Island Vacuum Plant

During the blower door test and thermal imaging of the Island Vacuum Plant, several large building leaks were identified that should be repaired. The worst were the intake and exhaust dampers for the emergency generator, the fresh air damper for the building, and the draft damper for the #2 boiler. All of these should be repaired.

From Table 4.2.3, the approximate total cost to heat the island vacuum plant is \$3,760. This is a heating cost per square foot of approximately \$3.36 which indicates that the losses through these leaks are significant. A 15% reduction in the overall heating cost would be a conservative estimate. This would be an annual savings of approximately \$564.

None of the dampers need to be replaced except the draft damper on boiler #2. The rest can be repaired. The cost to replace the draft damper and repair the others including travel and labor for a qualified mechanical technician would be approximately \$3,500.
