# Comprehensive Energy Audit For

## Circle Washeteria

Prepared For  
**Circle Native Community**

**April 28, 2017**

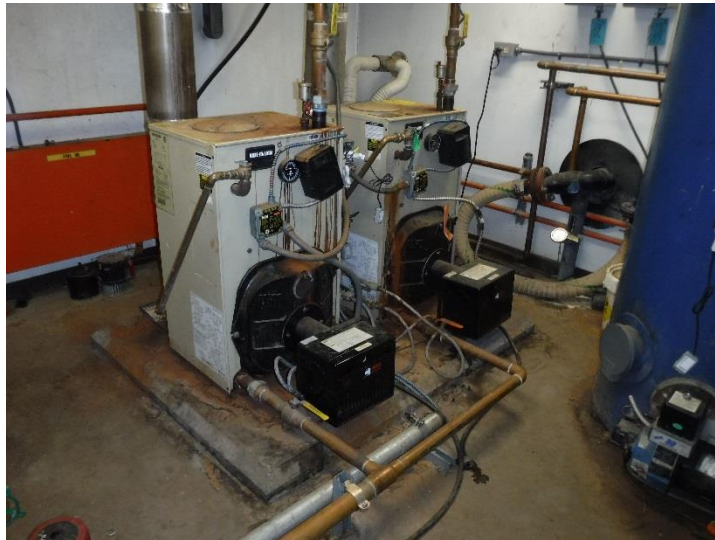
Figure 1: Fuel Oil Boilers in the Circle Washeteria

## Boiler 2

Nameplate Information: Weil McLain Gold  
WGO-4 Series 3  
Fuel Type: #1 Oil  
Input Rating: 126,000 BTU/hr  
Steady State Efficiency: 78 %  
Idle Loss: 0.5 %  
Heat Distribution Type: Water  
Boiler Operation: Oct – May

17	Heating, Ventilation, and Domestic Hot Water	Clean boilers, lower hot water heater set point, repair heat circulation pumps to ensure proper heat flow, convert heating system to primary secondary, replumb hydronic loop for more efficient heat delivery, repair unit heaters in the mechanical room and washeteria room to allow minimal use of the Toyo stove, Add thermostats and control valves to baseboard heating elements in each of the two restrooms.  Equipment repairs made in this retrofit are critical to the success of all retrofits involving thermostat setbacks, heat tape usage reduction, and pressure pump savings.	\$67	\$35,500	0.03	531.2	272.1
	<b>TOTAL, all measures</b>		<b>\$14,785</b>	<b>\$52,050</b>	<b>3.35</b>	<b>3.5</b>	<b>58,165.0</b>

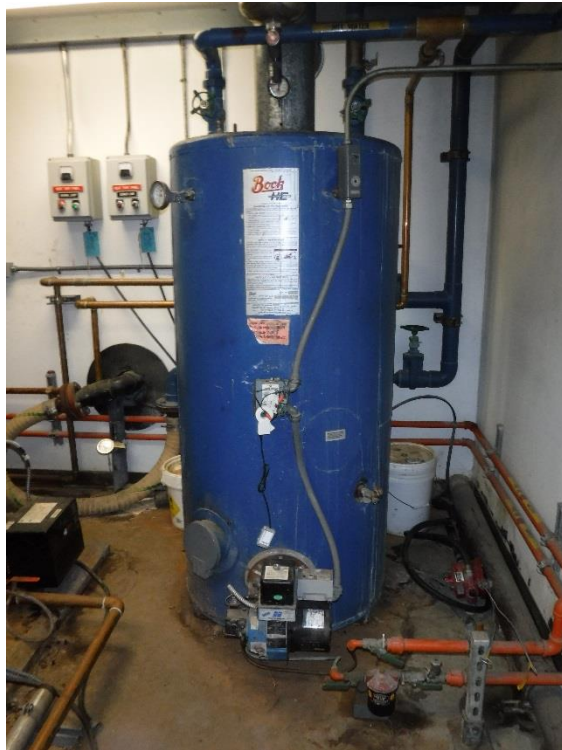
Figure 2: Hot Water Heater in the Circle Washeteria

## Hot Water Heater

Fuel Type: #1 Oil  
Input Rating: 100,000 BTU/hr  
Steady State Efficiency: 75 %  
Idle Loss: 0.5 %  
Heat Distribution Type: Water  
Boiler Operation: All Year

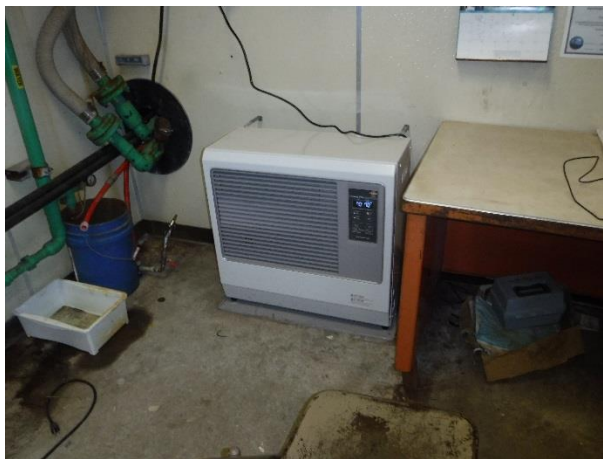
Figure 3: Toyo Laser 73 in the Circle Washeteria

### Toyotomi Laser 73

Fuel Type:	#1 Oil
Input Rating:	40,000 BTU/hr
Steady State Efficiency:	90 %
Idle Loss:	0 %
Heat Distribution Type:	Air

The water treatment plant space is heated by a Toyo Laser 73 stove that has a rating of 40,000 BTU/hr. There are other stoves in the plant that are old and not connected for use.

Rank	Building Space	Recommendation			
4	Mechanical Room	Implement a Heating Temperature Unoccupied Setback to 55.0 deg F for the Mechanical Room space.			
<b>Installation Cost</b>	\$500	<b>Estimated Life of Measure (yrs)</b>	15	<b>Energy Savings (\$/yr)</b>	\$313
<b>Breakeven Cost</b>	\$4,188	<b>Simple Payback (yrs)</b>	2	<b>Energy Savings (MMBTU/yr)</b>	14.2 MMBTU
		<b>Savings-to-Investment Ratio</b>	8.4		
<p>Auditors Notes: This can be achieved through programming of the Toyo Laser 73 Stove.</p>

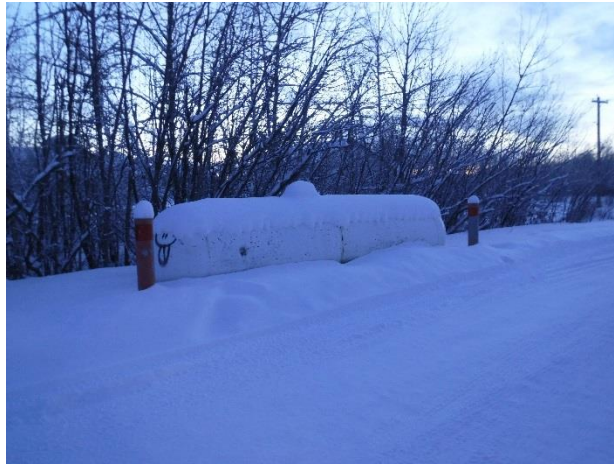
Figure 4: Propane Tank outside the Circle Washeteria

## Propane for Dryers

Fuel Type:	Propane
Input Rating:	100,000 BTU/hr
Steady State Efficiency:	80 %
Idle Loss:	0 %
Heat Distribution Type:	Water
Boiler Operation:	All Year

The clothes dryers in the washeteria use propane as the primary heat source. The propane is stored in a 2000 gallon storage tank outside of the facility.

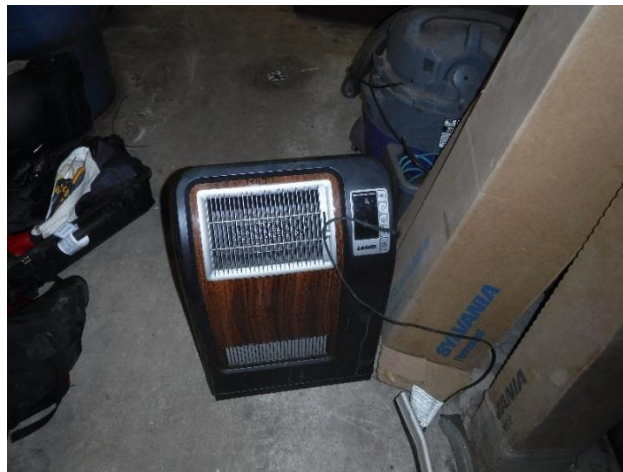
Figure 5: Portable Electric Heater in the Circle Washeteria

## Electric Heater – Portable

Fuel Type:	Electricity
Input Rating:	0 BTU/hr
Steady State Efficiency:	90 %
Idle Loss:	0 %
Heat Distribution Type:	Air

Rank	Location	Description of Existing	Efficiency Recommendation		
16		Electric Space Heating	Eliminate use of electric heater when unit heater is repaired.		
<b>Installation Cost</b>	\$2,000	<b>Estimated Life of Measure (yrs)</b>	15	<b>Energy Savings (\$/yr)</b>	\$60
<b>Breakeven Cost</b>	\$856	<b>Simple Payback (yrs)</b>	33	<b>Energy Savings (MMBTU/yr)</b>	3.9 MMBTU
		<b>Savings-to-Investment Ratio</b>	0.4		
Auditors Notes: When the unit heater is repaired, the electric heater that is currently used to heat the washeteria space on occasion will not be needed to heat the space.

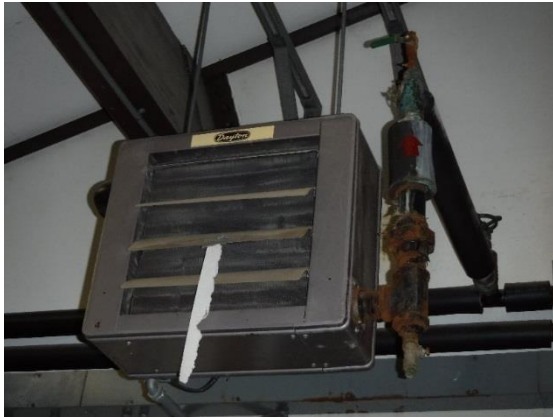
**Figure 6: Broken Unit Heaters in the Circle Washeteria**

There are three unit heaters in the building. Two are not in operation because they have corroded out. There is one functional unit heater in the washeteria space that has a leak in the piping, causing the water in the hydronic system to leak out and reducing the effectiveness of the heat distribution. For this reason, the unit heater is unable to meet the temperature setpoint of 75 degrees currently in the washeteria space. Additionally, the leaks cause the hydronic system to lose pressure, which forces the operator to pressurize the system each day by adding more water.

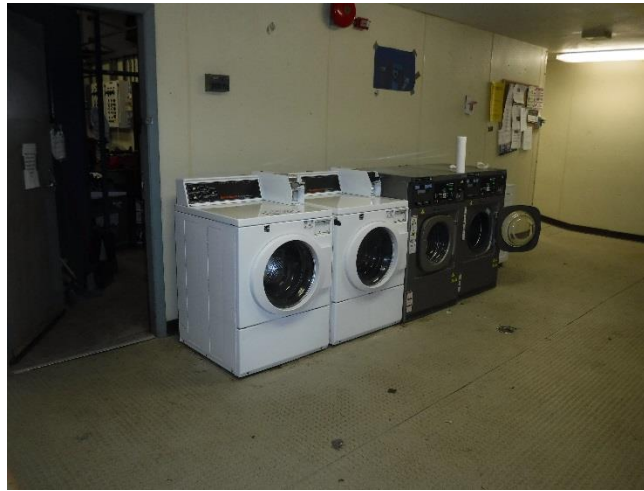
Figure 8: Clothes Washers in the Circle Washeteria

The washeteria is estimated to provide three loads of laundry through the clothes washer and dryers each day and approximately five showers per day. This yields an average hot water usage of approximately 67 gallons per day. The water is heated to 140 deg. F by an independent hot water heater.

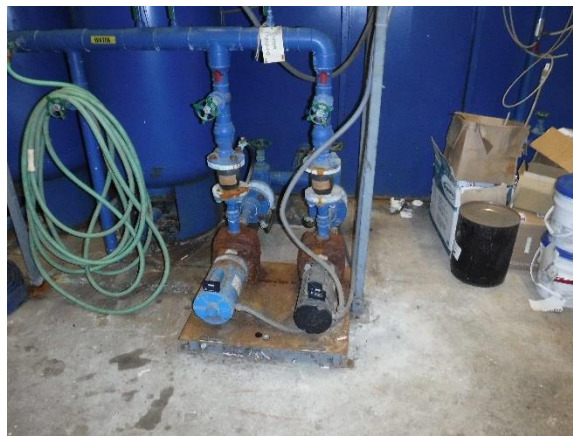
**Figure 9: Pressure Pumps in the Circle Washeteria**

The pressure pumps are used to maintain pressure in the system when the watering point has been used by a resident or from use of the services to the school and the tribal hall. The pumps were measured to operate approximately 5% of the time.

Rank	Location	Description of Existing	Efficiency Recommendation
6	Pressure Pump	Pressure Pump	Repair leaks in the hydronic system to minimize the operations of the pressure pumps.
<b>Installation Cost</b>	\$500	<b>Estimated Life of Measure (yrs)</b>	15
<b>Breakeven Cost</b>	\$1,529	<b>Simple Payback (yrs)</b>	4
		<b>Savings-to-Investment Ratio</b>	3.1
Auditors Notes: The leaks in the hydronic system bleed the pressure out throughout the day and require the pressure pumps to run more often to keep the system pressurized. This also requires the system to be filled with water on a daily basis. Repairing this leak will improve the efficiency and preserve the life of the motor.

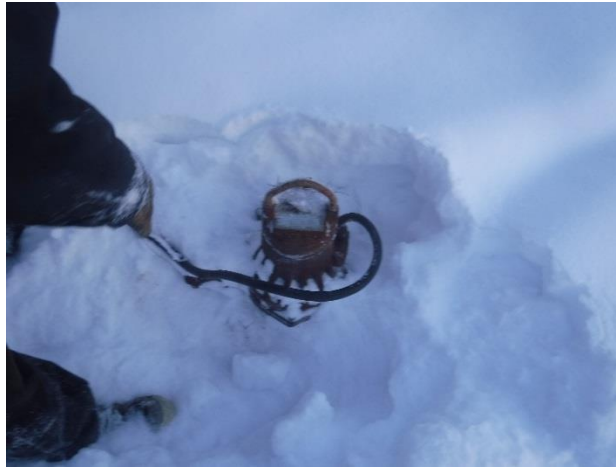
**Figure 10: Spare Lift Station Pump outside the Circle Washeteria**

The lift station pump is located in the underground wet well next to the washeteria and is used to pump sewage and wastewater from the washeteria to the sewage lagoon outside of town. The pump is rated for 3 HP.

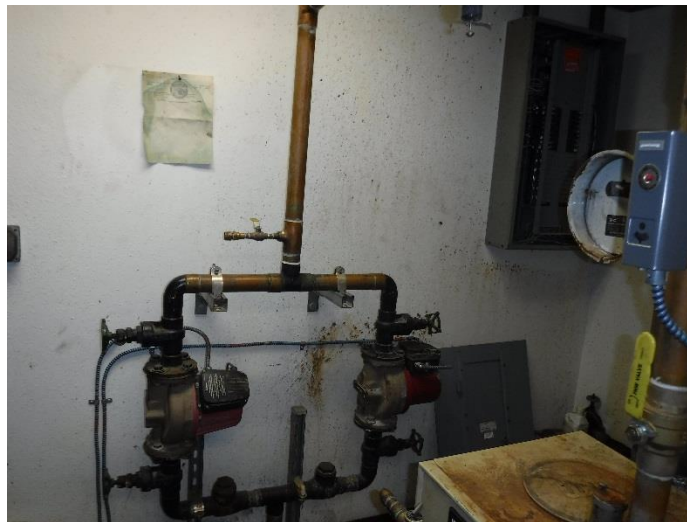
**Figure 11: Heat Circulation Pumps in the Circle Washeteria**

There are two circulation pumps in the hydronic heating system that are used to move the heated water from the boilers to the heat loads in the building. These pumps are rated for 1,050 Watts and consume approximately 5,652 kWh annually.

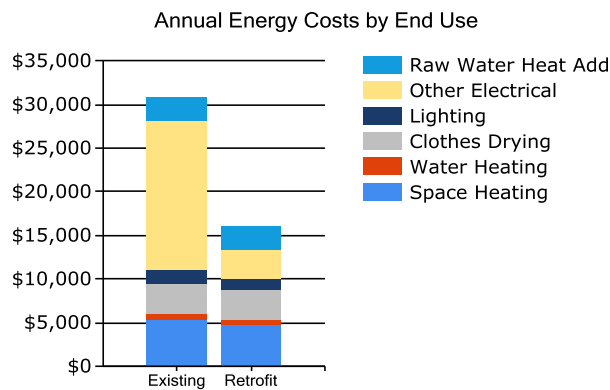
**Figure 13: Annual Energy Costs by End Use**

Figure 13 below reflects the estimated distribution of costs across the primary end uses of energy based on the AkWarm© computer simulation. Comparing the “Retrofit” bar in the figure to the “Existing” bar shows the potential savings from implementing all of the energy efficiency measures shown in this report.

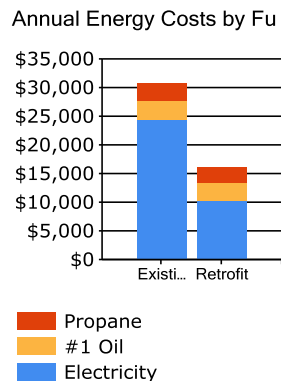
**Figure 14: Annual Energy Costs by Fuel Type**

Figure 14 below shows how the annual energy cost of the building splits between the different fuels used by the building. The “Existing” bar shows the breakdown for the building as it is now; the “Retrofit” bar shows the predicted costs if all of the energy efficiency measures in this report are implemented.

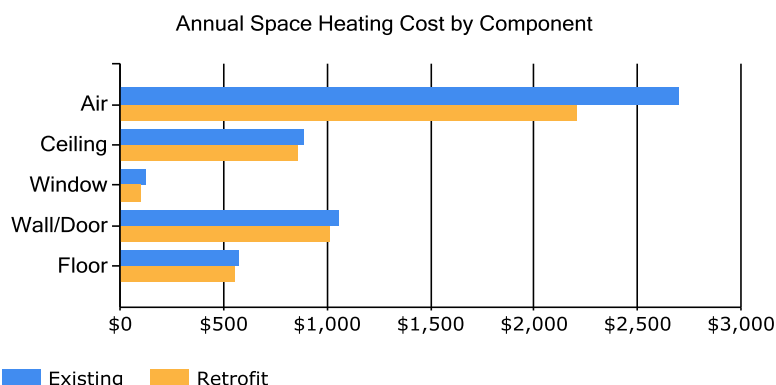
**Figure 15: Annual Space Heating Costs**

Figure 15 below addresses only Space Heating costs. The figure shows how each heat loss component contributes to those costs; for example, the figure shows how much annual space heating cost is caused by the heat loss through the Walls/Doors. For each component, the space heating cost for the Existing building is shown (blue bar) and the space heating cost assuming all retrofits are implemented (yellow bar) are shown.

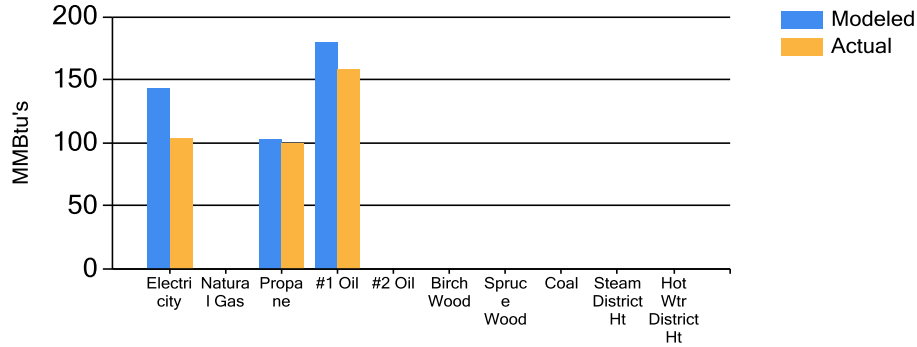
### Annual Energy Use

The graphs below show the modeled energy usage results of the energy audit process compared to the actual energy usage report data. The model was completed using AkWarm modeling software. The orange bars show actual fuel use, and the blue bars are AkWarm’s prediction of fuel use.
