Comprehensive Energy Audit For Buckland Washeteria

Prepared For
City of Buckland

May 12, 2017

**Alaska Native Tribal Health Consortium
4500 Diplomacy Dr., Suite 454
Anchorage, AK 99508**

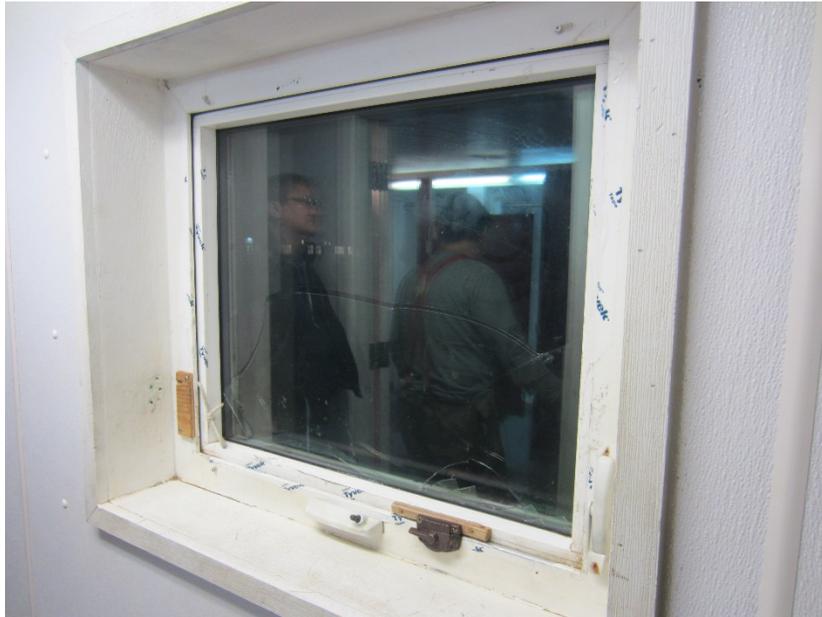
The building contains a total of 5 windows. All windows are 3' x 2'8" with double pane glass and wood and vinyl frames. One of the windows on the east facing side of the building has a broken pane. The opening and closing mechanisms on all windows are damaged. The windows do not seal properly.

Figure 2: Broken window in the Buckland Washeteria.

Rank	Location	Size/Type, Condition	Recommendation		
21	Window/Skylight: East Facing Window (Partially Broken)	Glass: Single, Glass Frame: Wood\Vinyl Spacing Between Layers: Half Inch Gas Fill Type: Air Modeled U-Value: 0.94 Solar Heat Gain Coefficient including Window Coverings: 0.52	Replace existing window with energy efficient, triple pane window.		
Installation Cost	\$1,164	Estimated Life of Measure (yrs)	20	Energy Savings (\$/yr)	\$5
Breakeven Cost	\$79	Simple Payback (yrs)	215	Energy Savings (MMBTU/yr)	0.8 MMBTU
		Savings-to-Investment Ratio	0.1		
Auditors Notes: One of the east-facing washeteria windows has a broken glass pane and open/close mechanism. The window does not seal properly. Replace this 2'8" x 3" window with an energy efficient, triple pane window.

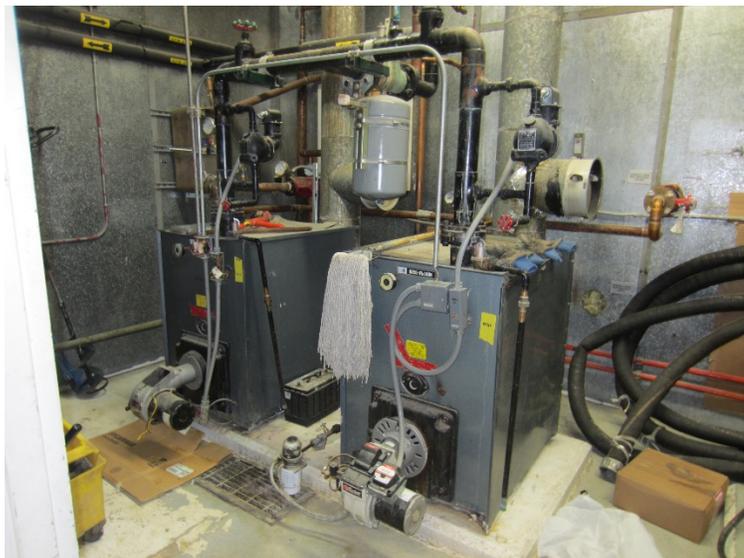
The majority of the demand for heat is met by a heat recovery system. The washeteria contains two Weil McLain boilers that supplement the heat recovery system if needed. The boilers are plumbed directly into the primary hydronic heating loop. This plumbing configuration results in a constant flow of the primary loop’s heated glycol through the boilers, essentially heating them while they are off, resulting in unnecessary heat loss. The stacks on the boilers are oversized. At the time of the audit, Boiler 2 was not operational. Boiler 1 was not observed to fire during the audit because the heat recovery system was meeting the entire heating demand of the building.

Figure 3: Boilers in Buckland Washeteria.

Rank	Recommendation				
10	Insulate pipes on hydronic system, improve controls to reduce uncontrolled heat output, valve off unused boiler, clean and tune boilers, provide operator training on boiler operation and maintenance.				
Installation Cost	\$8,000	Estimated Life of Measure (yrs)	20	Energy Savings (\$/yr)	\$653
Breakeven Cost	\$11,332	Simple Payback (yrs)	12	Energy Savings (MMBTU/yr)	15.4 MMBTU
		Savings-to-Investment Ratio	1.4		
<p>Auditors Notes: The hydronic heating system contains uninsulated pipe that radiates heat resulting in uncontrolled heat output that contributes to excessively high temperatures in the washeteria boiler, mechanical room and attic space. Insulate pipe to reduce heat loss.</p> <p>Improve heating system controls by installing programmable thermostats in various heating zones to allow for more precise temperature control (mechanical room may be kept cooler than more frequently use laundry room space) and to further reduce heat loss.</p> <p>One boiler is sufficient to back up the heat recovery system and even meet the entire heating demand of the building in the case that the heat recovery system were to go offline. Valve off the second boiler to reduce flow of glycol and therefore heat loss through this unused boiler. Clean and tune boilers. Provide operators with training on boiler operation, maintenance and troubleshooting.</p> <p>More efficient, better controlled us of recovered heat in the washeteria will result in more heat being available to the water treatment plant as well, so upgrades to the heating system will result in reduced fuel use in both buildings.</p>
