# Investigative Energy Audit For Circle Tribal Office

Prepared For  
**Circle Native Community**

**May 31, 2017**

**Prepared By: Kevin Ulrich, CEM**

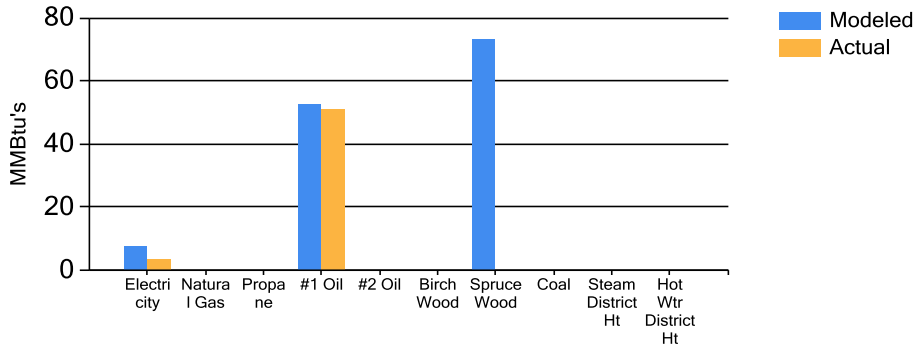
**Annual Energy Use**

The graphs below show the modeled energy usage results of the energy audit process compared to the actual energy usage report data. The model was completed using AkWarm modeling software. The orange bars show actual fuel use, and the blue bars are AkWarm’s prediction of fuel use.
