# Comprehensive Energy Audit For Chistochina Recreation Center

Prepared For  
**Cheesh'Na Tribe**

**March 21, 2019**

**Alaska Native Tribal Health Consortium  
4500 Diplomacy Drive  
Anchorage, AK 99508**

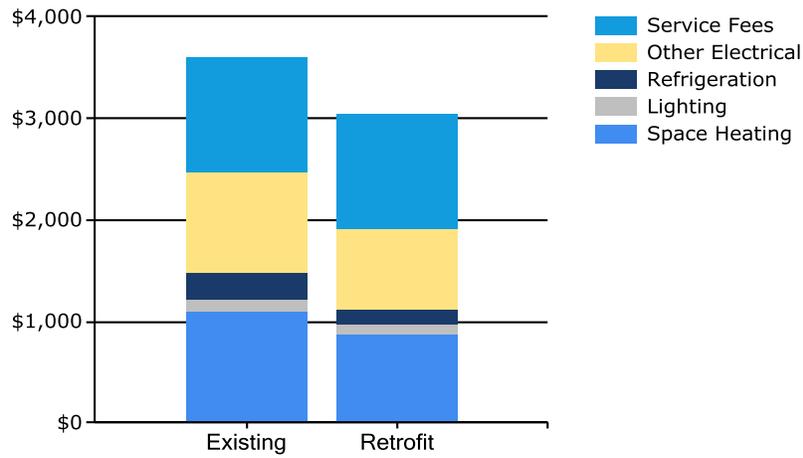
**Figure 1.1: Annual energy costs by use before and after EEMs.**

Figure 1.1 below reflects the estimated distribution of costs across the primary end uses of energy based on the AkWarm© computer simulation. Comparing the “Retrofit” bar in the figure to the “Existing” bar shows the potential savings from implementing all of the EEMs shown in this report. Figure 1.2 shows the change in fuel usage after the recommended EEMs are installed.

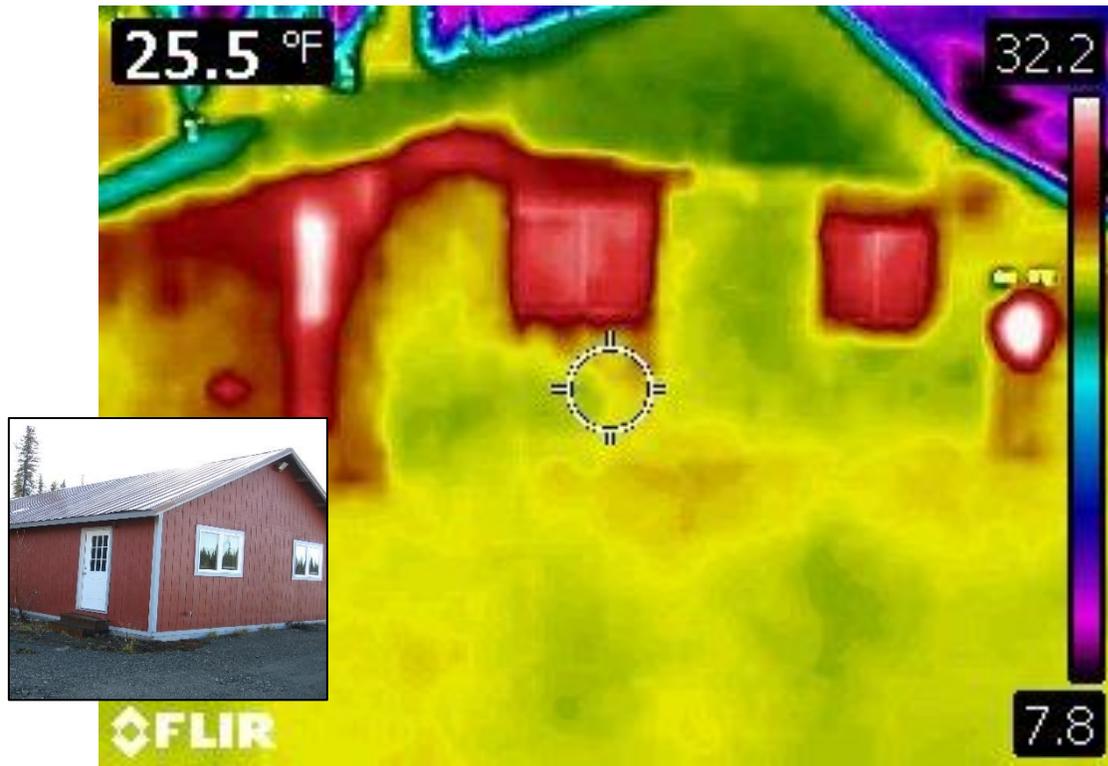
**Figure B1.** Thermal imaging of the Chistochina Recreation Center (inset photo actual building). The color gradient on the right corresponds to degrees Fahrenheit, ranging from white (31.9°F) to black (-6.6°F). The areas of white and red demonstrate a large amount of heat loss through the Center’s windows and doors.

The exterior of the building is stick built: 2x6 framing with 16” on-center studs. The stud cavity is filled with R-19 fiberglass batt insulation. There are concerns about the age of the stud cavity insulation and the quality of the installation, so the insulation likely needs to be replaced. The building crawlspace was recently insulated with 4” of extruded polystyrene (EPS, otherwise known as Styrofoam) to protect the pellet boiler district heating hydronic plumbing. Aside from a short length of carrier pipe, the hydronic heating plumbing and building heat exchanger are uninsulated. The crawlspace door is uninsulated.

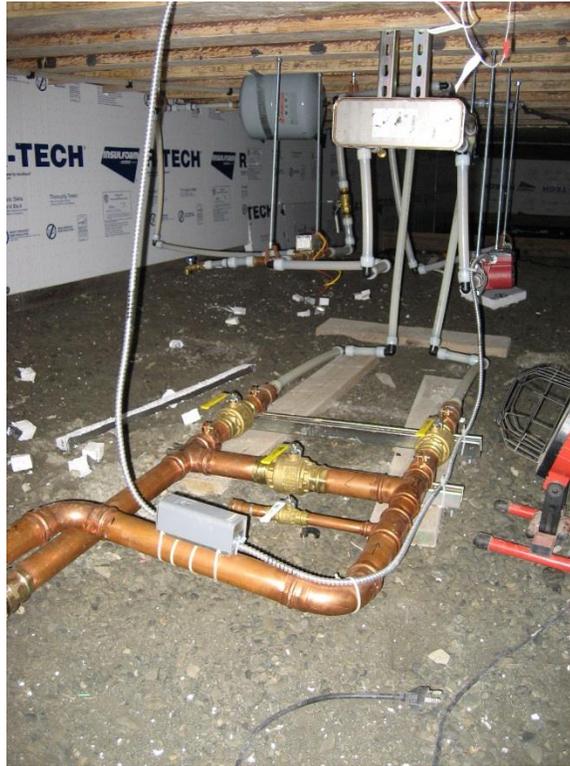
The exercise room is heated year-round by a direct vent, oil-fired stove. A pellet-fired district heating boiler supplements the recreation center’s heat from November to June. Heated glycol is circulated between the pellet boiler building and the Chistochina Community Hall through about 90 linear feet of buried, insulated transmission line. Heat is transferred at the community hall to a secondary heating loop (about 200 linear feet of buried, insulated carrier pipe), which is connected to the recreation center’s hydronic heating system via a heat exchanger in the building’s crawlspace. As mentioned above and illustrated in Figure B2, the building’s hydronic heating system plumbing and heat exchanger are uninsulated, but the crawlspace is insulated (4” EPS foam board).

**Figure B2. Uninsulated hydronic heating plumbing and heat exchanger in the Recreation Hall crawlspace.**

7	Heating, Ventilation, and Domestic Hot Water	Insulate all district heating hydronic heating plumbing and the heat exchanger in the building crawlspace.	\$26	\$900	0.60	34.4
8	Lighting: Seasonal Office Space	Remove the ballasts in the four-bulb overhead lights. Install direct wire, energy efficient LED equivalents. Cost estimate includes one tombstone per bulb.	\$19 + \$15 Maint. Savings	\$826	0.59	24.1
9	Lighting: Seasonal Office Space	Remove the ballasts in the two-bulb overhead lights. Install direct wire, energy efficient LED equivalents. Cost estimate includes one tombstone per bulb.	\$2 + \$2 Maint. Savings	\$83	0.59	24.1
10	Shell Improvements: Ceiling	Add unfaced R-11 fiberglass batt to the attic space.	\$34	\$1,557	0.51	45.4
11	Electrical Controls: Television and VCR	Unplug the television and VCR in the exercise room when not in use. Estimated 2% electrical usage reduction.	\$1	\$25	0.34	24.4

There is not adequate heat transfer at the community hall to the recreation center heating loop. The Chistochina Community Hall has a large heating demand and typically uses most of the available district heat. The Cheesh’Na Tribe plans to replace the existing Recreation Center circulation pump with a larger pump to increase the heating loop circulation and provide more heat to the building.

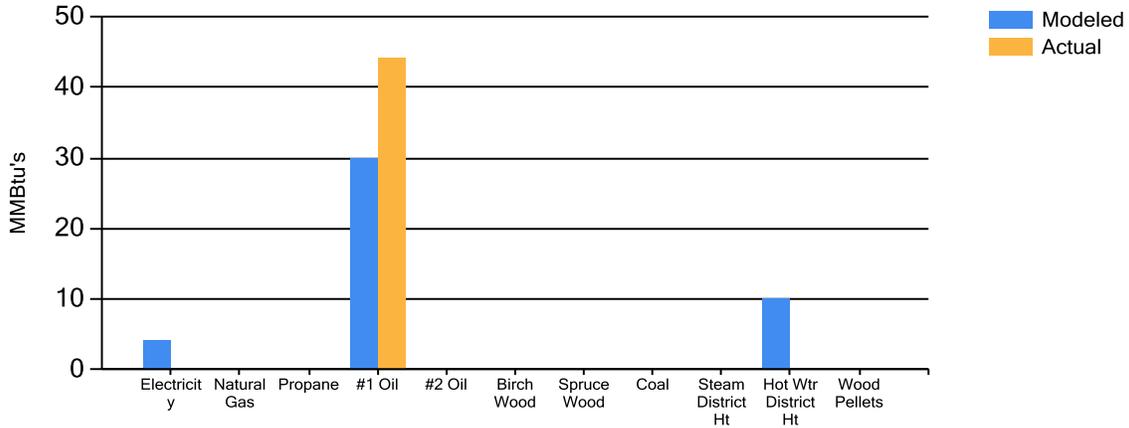
### Annual Fuel Use

The graphs below show the modeled energy usage results of the energy audit process compared to the actual energy usage report data. The model was completed using AkWarm© modeling software. The orange bars show actual fuel use, and the blue bars are AkWarm©’s prediction of fuel use.

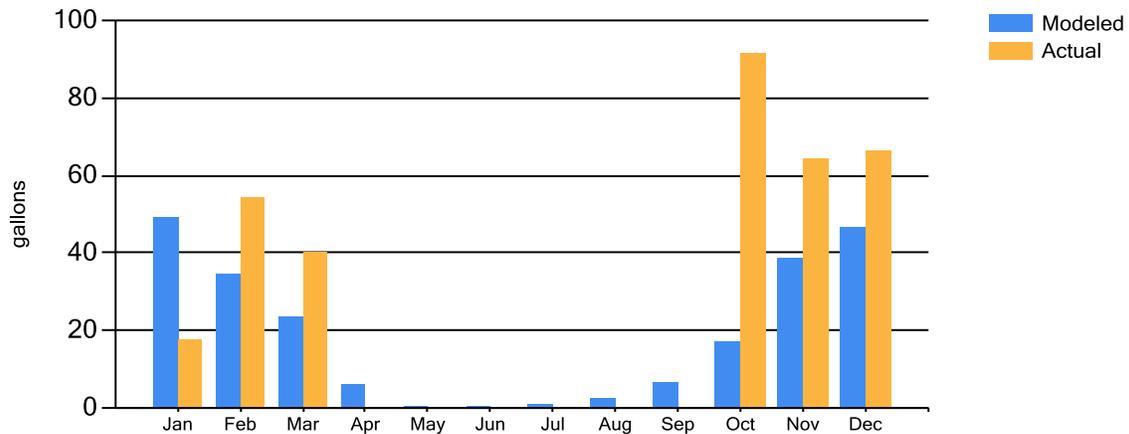
### #1 Fuel Oil Fuel Use

Note: The "actual" fuel usage above is by delivery, not the amount used during the month.

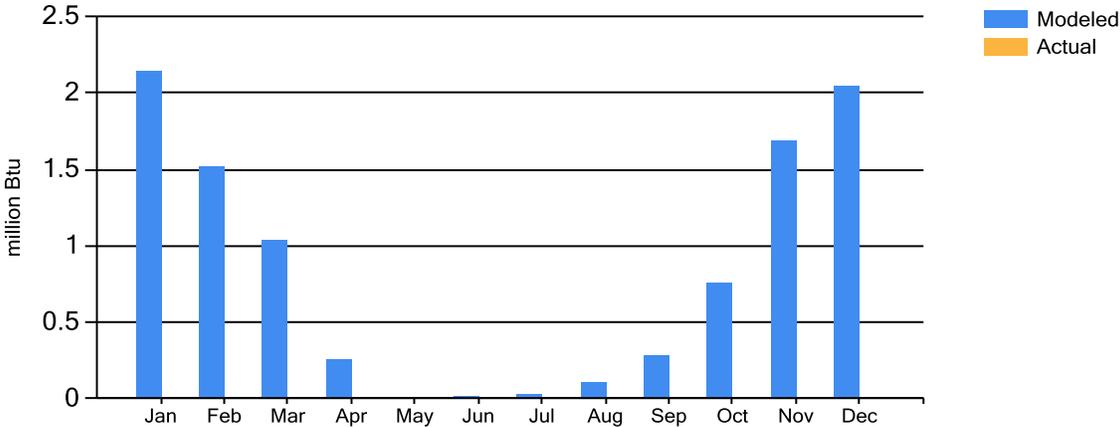
**Pellet-Fired District Heating System**

*Note: The pellet-fired boiler is only used from November through June. Any heating requirements in the chart above would be supplied by the direct vent, oil-fired stoves.*
