Comprehensive Energy Audit For Chistochina Water Building

Prepared For
Cheesh'Na Tribe

March 19, 2019

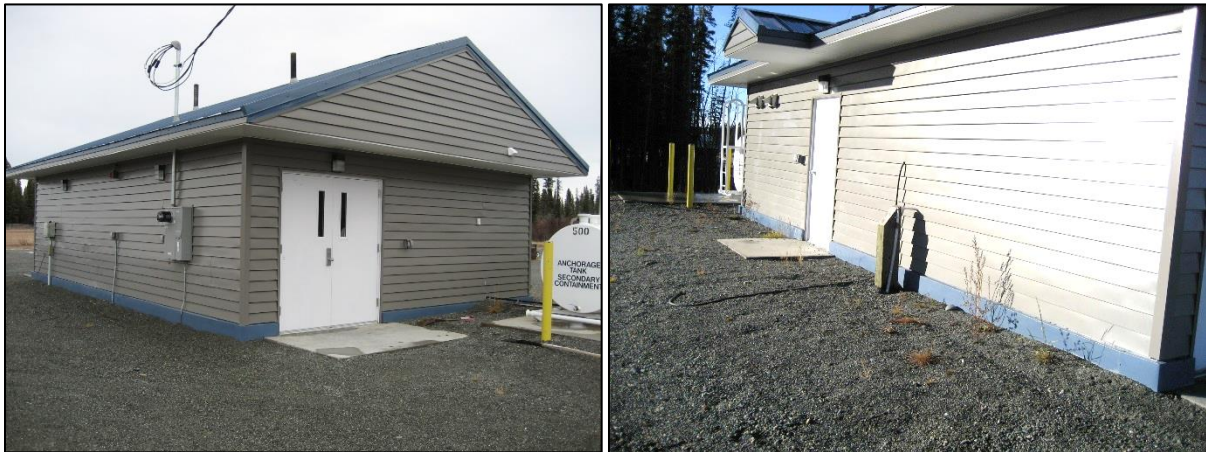
Figures 1.1 a) and b): Chistochina Water Building exterior.

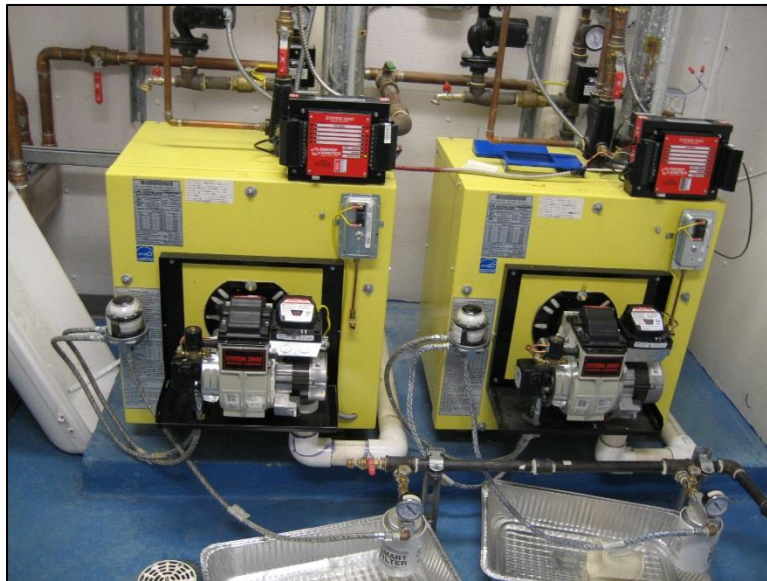
Two Energy Kinetics System 2000 boilers provide space heating, glycol heat trace, and domestic hot water (DHW) through an indirect hot water generator. Zone valves control the heat distribution throughout the building. See Appendix A for additional information.

Figure 1.2: Chistochina Water Building boilers.

Rank	Recommendation					
3	Clean and tune boilers. Perform annual efficiency testing. Troubleshoot and reconnect Tekmar 262. Set lead lag boilers, and alternate boilers to decrease wear and tear. Boiler circulation pumps should run only when boilers are running. Primary loop circulators should respond based on calls for heat. Troubleshoot zone valve Z1 (Process Room unit heater). May need to be replaced. Insulate all hydronic heating and DHW plumbing in the boiler/pump room. Label all components. Provide wall chart and troubleshooting guide for Tekmar 262 controller.					
Installation Cost		\$5,400	Estimated Life of Measure (yrs.)	20	Energy Savings (\$/yr.)	\$742
Breakeven Cost		\$11,618	Simple Payback (yrs.)	7	Energy Savings (MMBTU/yr.)	16.3 MMBTU
			Savings-to-Investment Ratio	2.2		
Auditors Notes:						
Performing annual maintenance on boilers is critical for maintaining combustion and heat transfer efficiency. Typically performed in the fall, boiler maintenance includes:

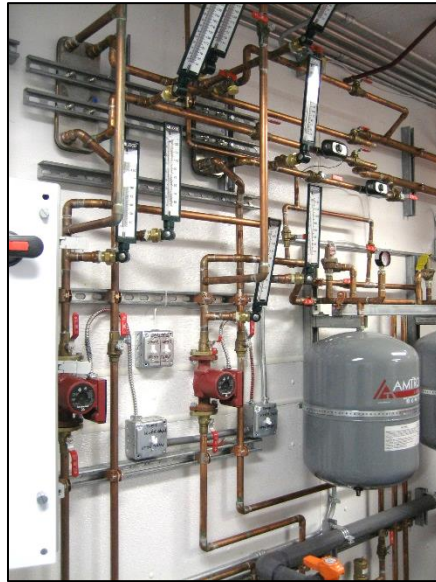
The water and E/one sewer lines have glycol heat trace lines installed along the mains. The glycol heat trace system is operated intermittently throughout the winter, depending on the water supply pressure, and in April when the frost line is pushed below the water and sewer mains.

Figure 1.5: Water Building water and sewer glycol heat trace controls and heat exchangers.

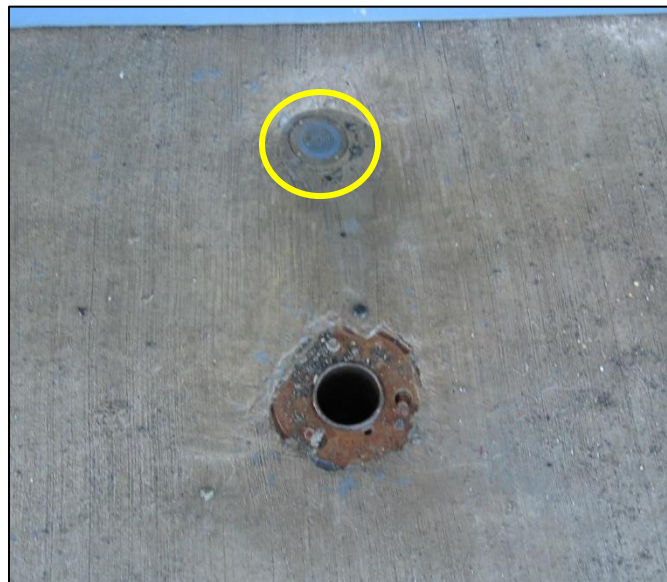
The public watering point drain has a glycol heat trace to prevent ice buildup. The heat trace zone valve is opened once the ice sensor installed in the pad becomes iced over.

Figure 1.6: Honeywell Ice Sensor for the watering point drain heat trace.

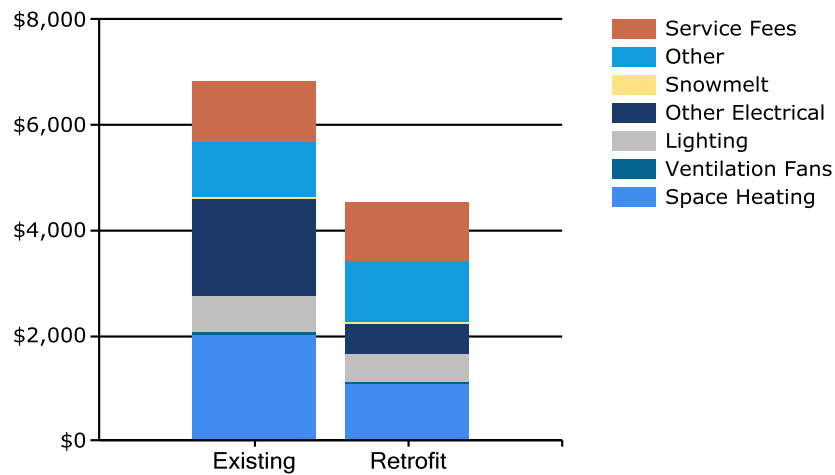
Figure 2.1 below reflects the estimated distribution of costs across the primary end uses of energy based on the AkWarm© computer simulation. Comparing the “Retrofit” bar in the figure to the “Existing” bar shows the potential savings from implementing all of the energy efficiency measures shown in this report.

Figure 2.1: Annual energy costs by use before and after EEMs.
