Comprehensive Energy Audit  
For  
Too'gha, Inc. Water and Sanitation System Facilities

Prepared For  
**Too'gha Inc.**

**January 16, 2018**

**Alaska Native Tribal Health Consortium  
4500 Diplomacy Dr., Suite 454  
Anchorage, AK 99508**

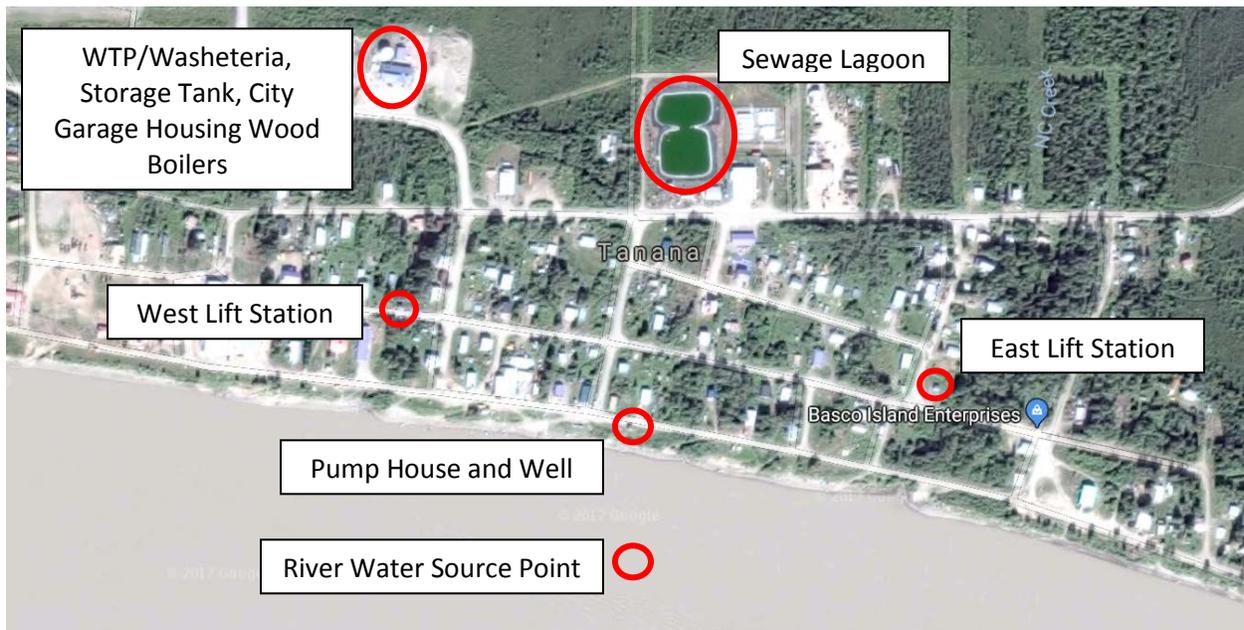
Figure 1: Aerial view of Tanana Water system Facilities

The Too'gha water and sanitation system is comprised of a main combination water treatment plant and laundromat building along with four auxiliary facilities including a garage that houses the biomass boilers, two lift stations and a pump house. The primary 4,608 square foot WTP/Laundromat building was constructed around 2002. Two operators manage the water and sanitation system seven days a week, passing in and out of the water treatment plant as they tend to the system components. The laundromat provides washer and dryer as well as hot shower service, however, the coin service hot showers were not operational at the time of the audit. The laundromat is open to the community from 10:00 am to 10:00 pm five days a week. It is closed on Tuesday and Thursday. A janitor arrives to clean the building each day that the laundromat is open from about 6:00 pm to 8:00 pm. Building occupancy fluctuates throughout the day from zero to six people.

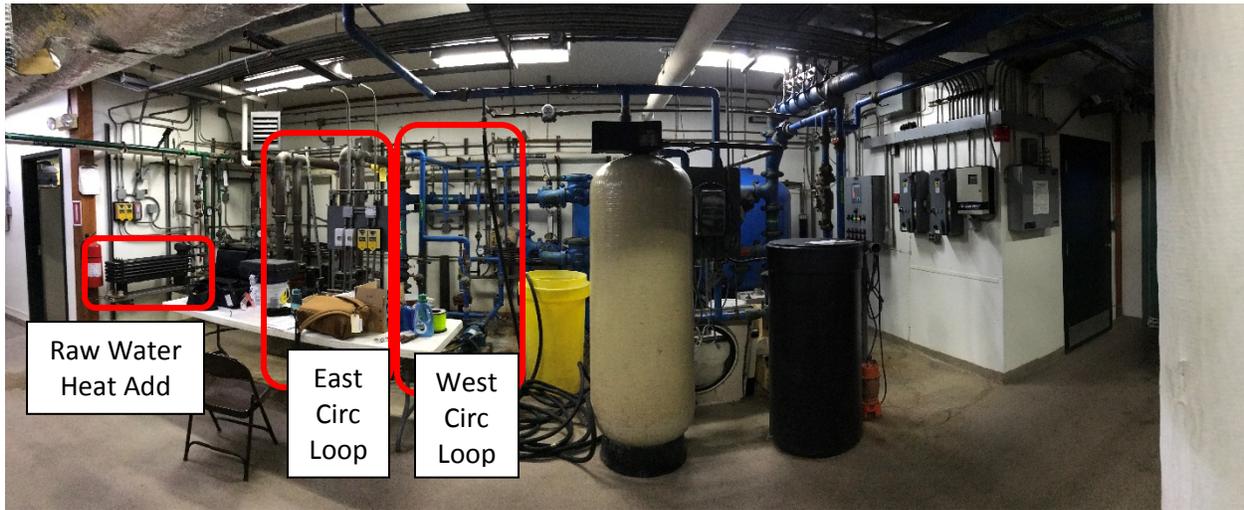
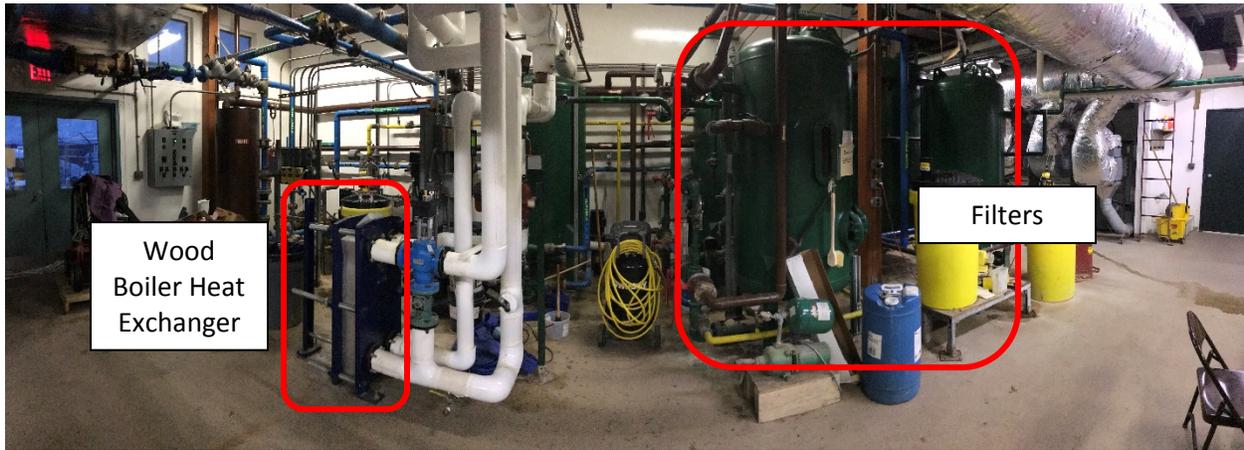
**Figure 2: Process and Distribution Room in the Too'gha Water Treatment Plant**

Water is delivered from the source to the WTP via an estimated 1750 feet of transmission line. A glycol heat trace circulates along the transmission line year round to prevent the line from freezing in the permafrost. After entering the WTP, heat is added to the raw water bringing it up to 48°F. The water is then chlorinated and passed through a catalytic media filter tank to oxidize and remove iron and manganese. Polymer coagulant is added to the water which then passes through a static mixer and into a reaction tank. Here particles have time to bond, forming larger particles that are more easily removed as the water then passes through two multi-media (anthracite, sand and garnet) filters. Next, the water passes through a granular activated carbon (GAC) tank where organic chemicals are removed. Finally,

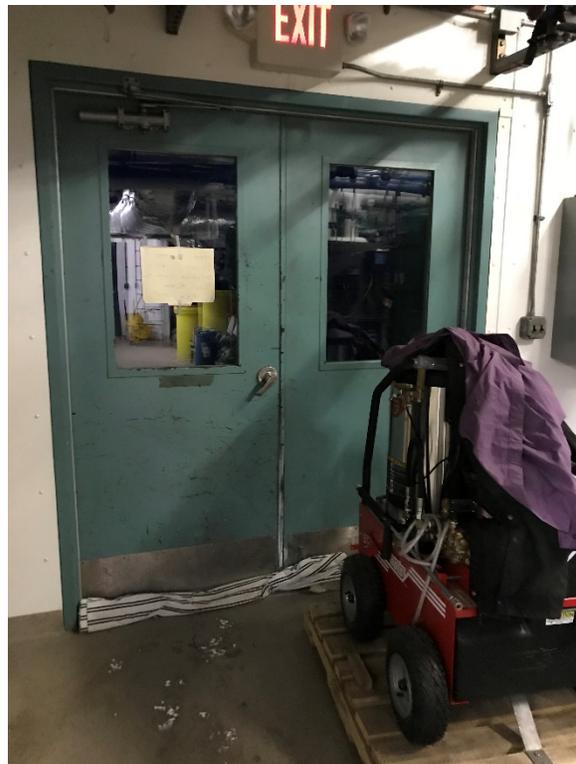
**Figure 3: Rags are used to mitigate air leakage under the process room doors.**

There is a metal 3' x 6'8" front entry door with an arctic entry and another metal 3' x 6'8" door (no arctic entry) on the back side of the laundromat room in need of air sealing. There is a metal set of two 3'6" x 6'8" doors on the west side of the process room as well. Significant air leakage is visible along the bottom of the process room doors.

Rank	Location	Existing Air Leakage Level (cfm@50/75 Pa)	Recommended Air Leakage Reduction (cfm@50/75 Pa)
22		Air Tightness estimated as: 11474 cfm at 50 Pascals	Perform air sealing to reduce air leakage by 5%.
<b>Installation Cost</b>	\$500	<b>Estimated Life of Measure (yrs)</b>	10
<b>Breakeven Cost</b>	\$1,246	<b>Simple Payback (yrs)</b>	3
		<b>Savings-to-Investment Ratio</b>	2.5
<p>Auditors Notes: Air exchange was calculated using the following equation: Total CFM = square footage, 4608 sq ft x 2.49. The number 2.49 is based upon the guide in the help section and takes into consideration the air exchange correlated with absent air stripping on some doors, boiler makeup air, many recessed light fixtures and an open attic, and building ventilation system.</p> <p>This recommendation involves the replacement of threshold gaskets and air sealing of the back and side doors of the WTP/laundromat building.</p>

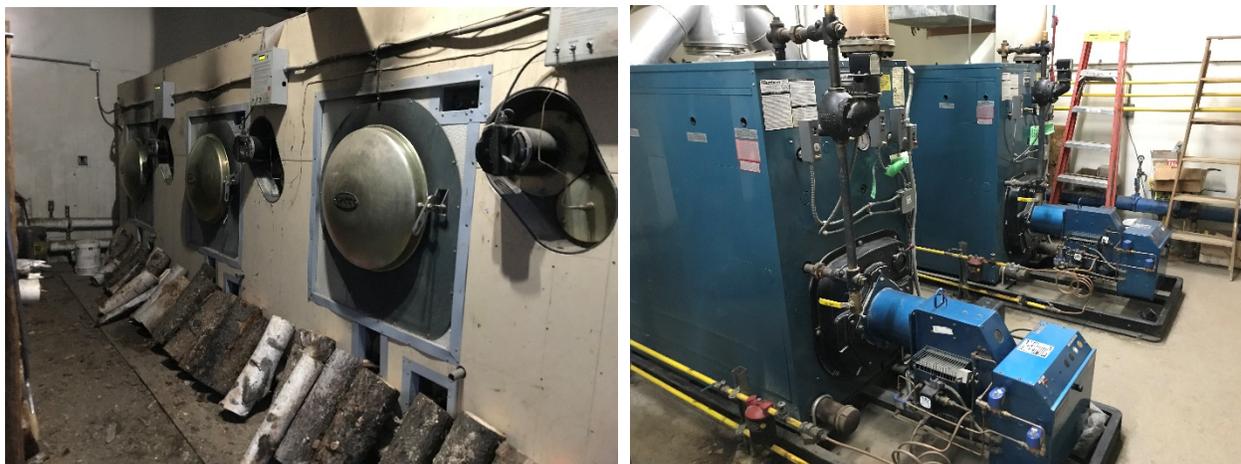
The demand for space heat in the WTP/Laundromat is seasonal, however, the washers and dryers demand heat year round. The raw water transmission line lies within a layer of permafrost, so the glycol heat trace that prevents this line from freezing also demands year round heat. Heat is supplied to the WTP and Laundromat by five different boilers. Three Garn 2000 Wood Fired Boilers located in a city garage behind the Laundromat serve as the primary heating source. Two large Burnham Oil-Fired boilers supplement the wood boilers when needed, although one of those was offline due to a burnt fuel line at the time of the audit visit.

<b>Garn 2000 Wood Fired Boiler</b>	<b>Burnham Oil Fired Boiler</b>
<b>Number of Identical Boilers</b>	3	2
<b>Fuel Type</b>	Wood (birch, spruce)	#2 Fuel Oil
<b>Input Rating</b>	311,000 BTU/hr	1,554,400 BTU/hr
<b>Steady State Efficiency</b>	76 %	80 %
<b>Idle Loss</b>	1.5 %	0.8 %
<b>Heat Distribution Type</b>	Water	Water
<b>Boiler Operation</b>	Year Round	Oct-May

**Figure 4: Left: Garn wood boilers located in the city garage behind the Laundromat. Right: Burnham oil-fired boilers located in the WTP.**

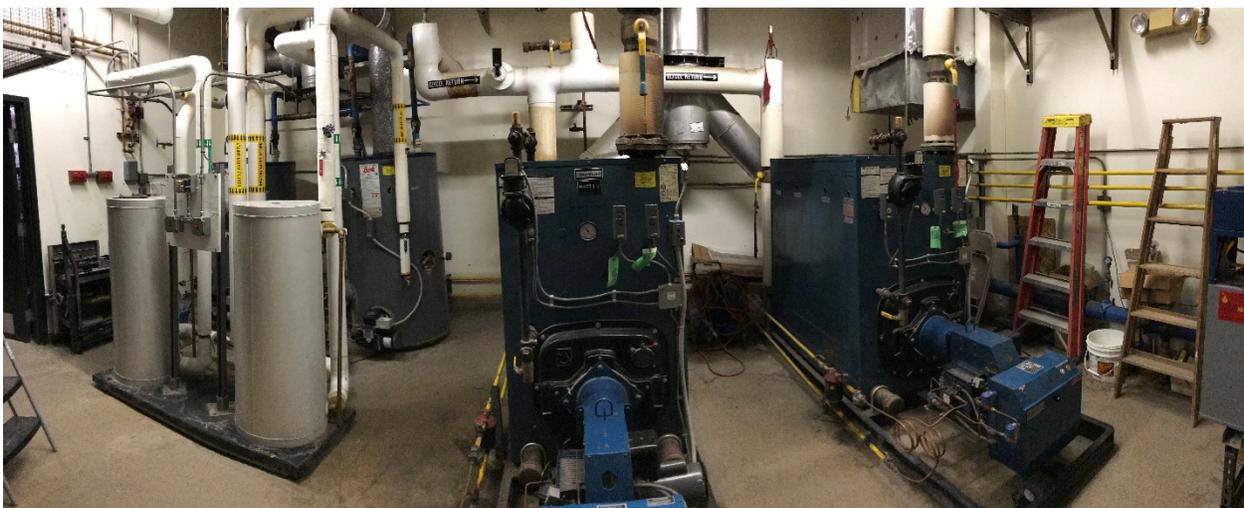
The wood boilers supply heat to two 45 gallon hot water generators. One hot water generator serves the washers and is set to heat to 140°F and the other serves all other hot water needs and is set to heat to 110°F. Two older 85 gallon hot water generators formerly served by the oil fired boilers now provide additional hot water storage.

**Figure 5: Left: The WTP/Laundromat Boiler Room. The white hot water generators on the left are served by the wood boilers. The older gray hot water generators behind them now serve as hot water storage tanks.**

Rank	Building Space	Recommendation			
17	Water Treatment Plant and Washeteria Boiler Room	Implement a Heating Temperature Unoccupied Setback to 60.0 deg F for the Water Treatment Plant and Washeteria Boiler Room space.			
<b>Installation Cost</b>	\$200	<b>Estimated Life of Measure (yrs)</b>	15	<b>Energy Savings (\$/yr)</b>	\$69
<b>Breakeven Cost</b>	\$835	<b>Simple Payback (yrs)</b>	3	<b>Energy Savings (MMBTU/yr)</b>	4.3 MMBTU
		<b>Savings-to-Investment Ratio</b>	4.2		
Auditors Notes: Heating temperature setbacks are recommended for all of the WTP/Laundromat spaces. Heating the building to 60 deg F during the night when the building is unoccupied will reduce diesel fuel consumption.

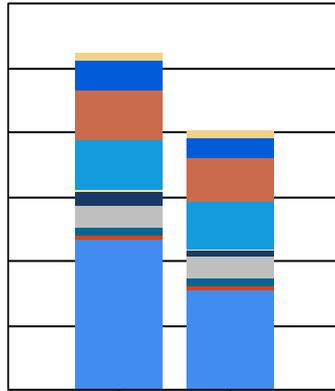
**Figure 3.1**  
**Annual Energy Costs by End Use**

Figure 3.1 below reflects the estimated distribution of costs across the primary end uses of energy based on the AkWarm© computer simulation. Comparing the “Retrofit” bar in the figure to the “Existing” bar shows the potential savings from implementing all of the energy efficiency measures shown in this report.

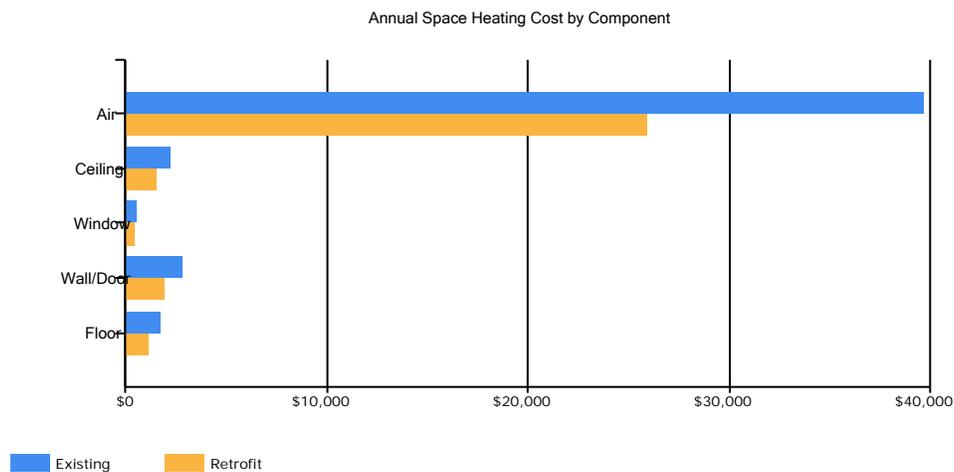
**Figure 3.3**  
**Annual Space Heating Cost by Component**

Figure 3.3 below addresses only Space Heating costs. The figure shows how each heat loss component contributes to those costs; for example, the figure shows how much annual space heating cost is caused by the heat loss through the Walls/Doors. For each component, the space heating cost for the Existing building is shown (blue bar) and the space heating cost assuming all retrofits are implemented (yellow bar) are shown.

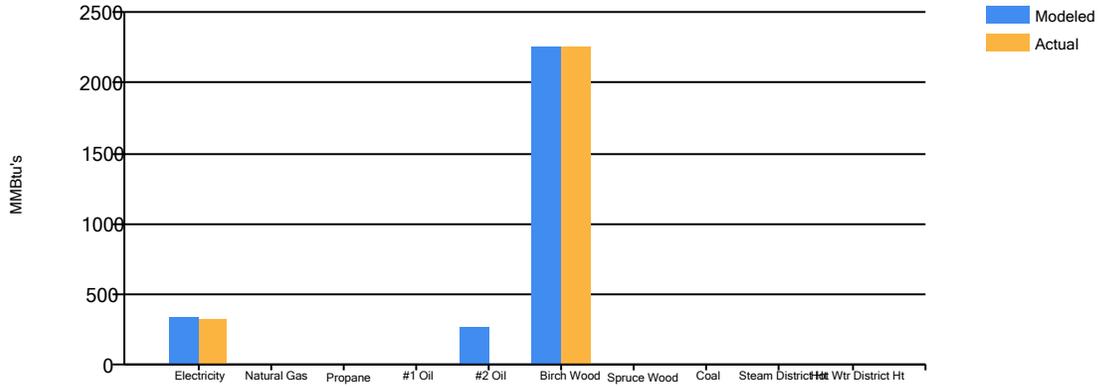
Annual Fuel Use

The Orange bars show Actual fuel use, and the Blue bars are AkWarm’s prediction of fuel use.
