Source Drinking Water Challenges Changes to an Arctic Tundra Lake

Center for Climate and Health

CCH Bulletin No. 2, October 19, 2009

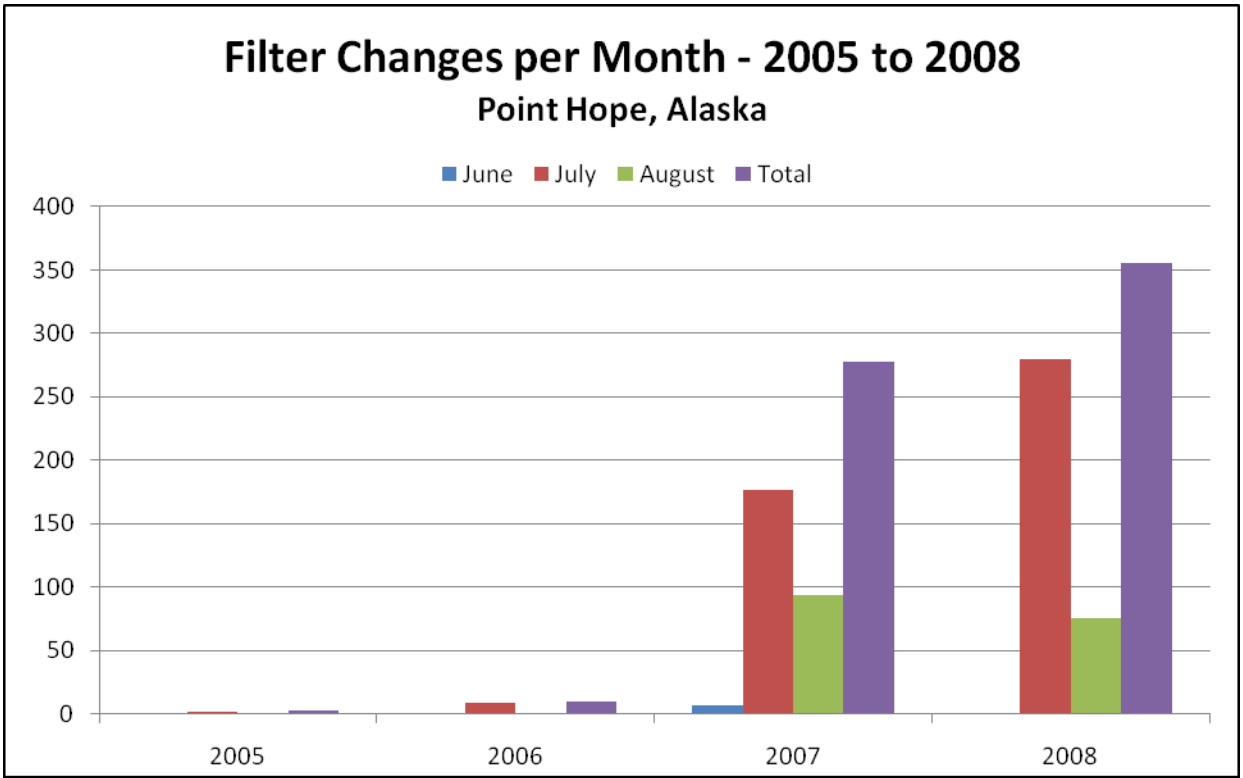
Fig. 2 Source: *Treatment Log Book, Point Hope Water Plant*

Figure 2 below shows the number of bag filter changes recorded per month from 2005 until 2008. Generally, the operators clean the bag filters two to four times per full 24 hour day. The 2005 and 2006 data reflect a lower bag clean rate, suggesting either that fewer filters were used, that filters were not cleaned regularly, or that there were not regular filter changes log book entries. Nevertheless, operators report that decreased water quality and increased filter cleaning only emerged as a problem in 2007-2008, and would not have been reflected in 2005-2006 log records.

Figure 2 also shows that the increasing number of bag changes occurred mostly in July. Figure 3 below shows the number of filter changes per day during July of 2007 and 2008. The number of filter changes here are seen to rise and fall in wave–like fashion, as if related to a physical or biological cycle. For the water utility, additional filter maintenance translates into hours of labor. At the peak disruption period in 2007, operators were changing filters over twenty times per day. In 2008 the number of bag changes at times rose to almost 50 times per day.

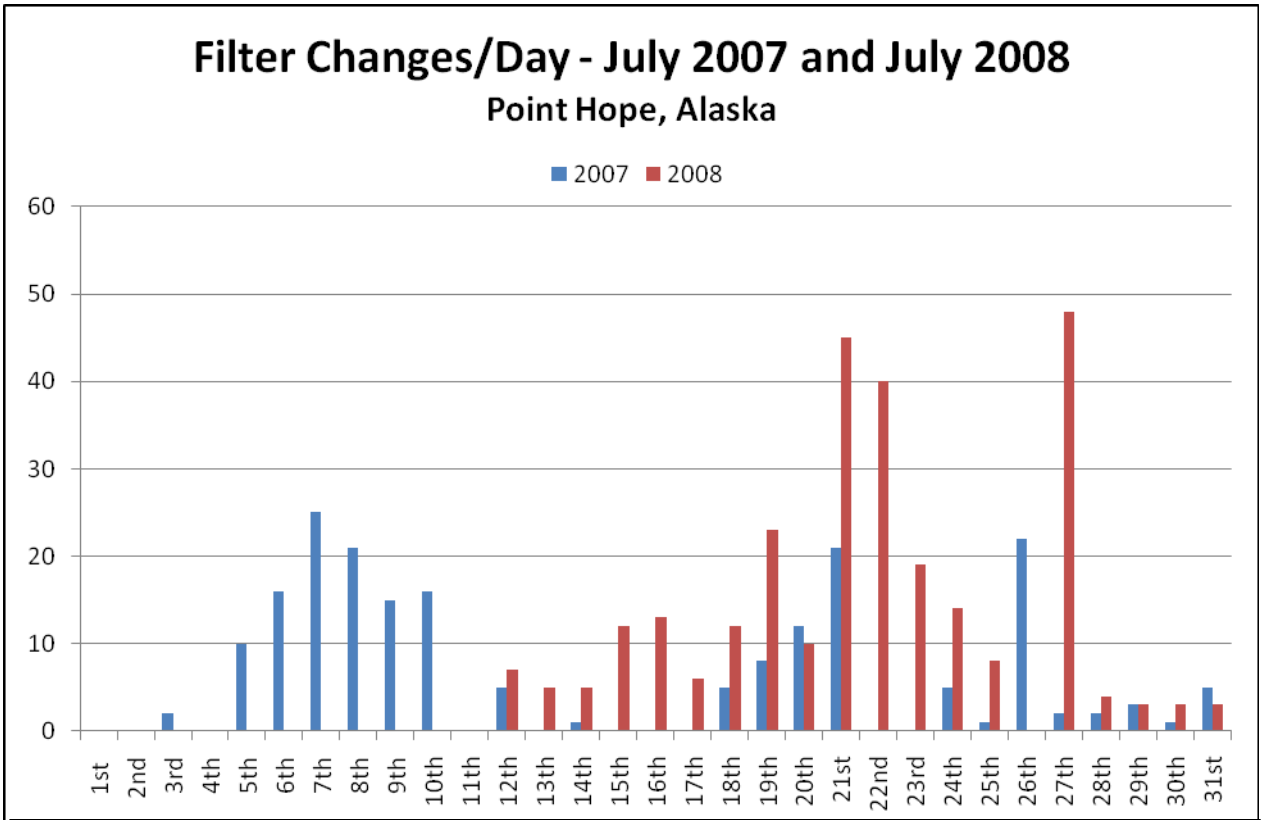
Fig. 3 Source: *Treatment Log Book, Point Hope Water*

On July 27, 2008, at the peak of the source water quality problem, Point Hope operators were spending approximately eight hours, or 1/3 of each 24 hour shift performing filter maintenance.

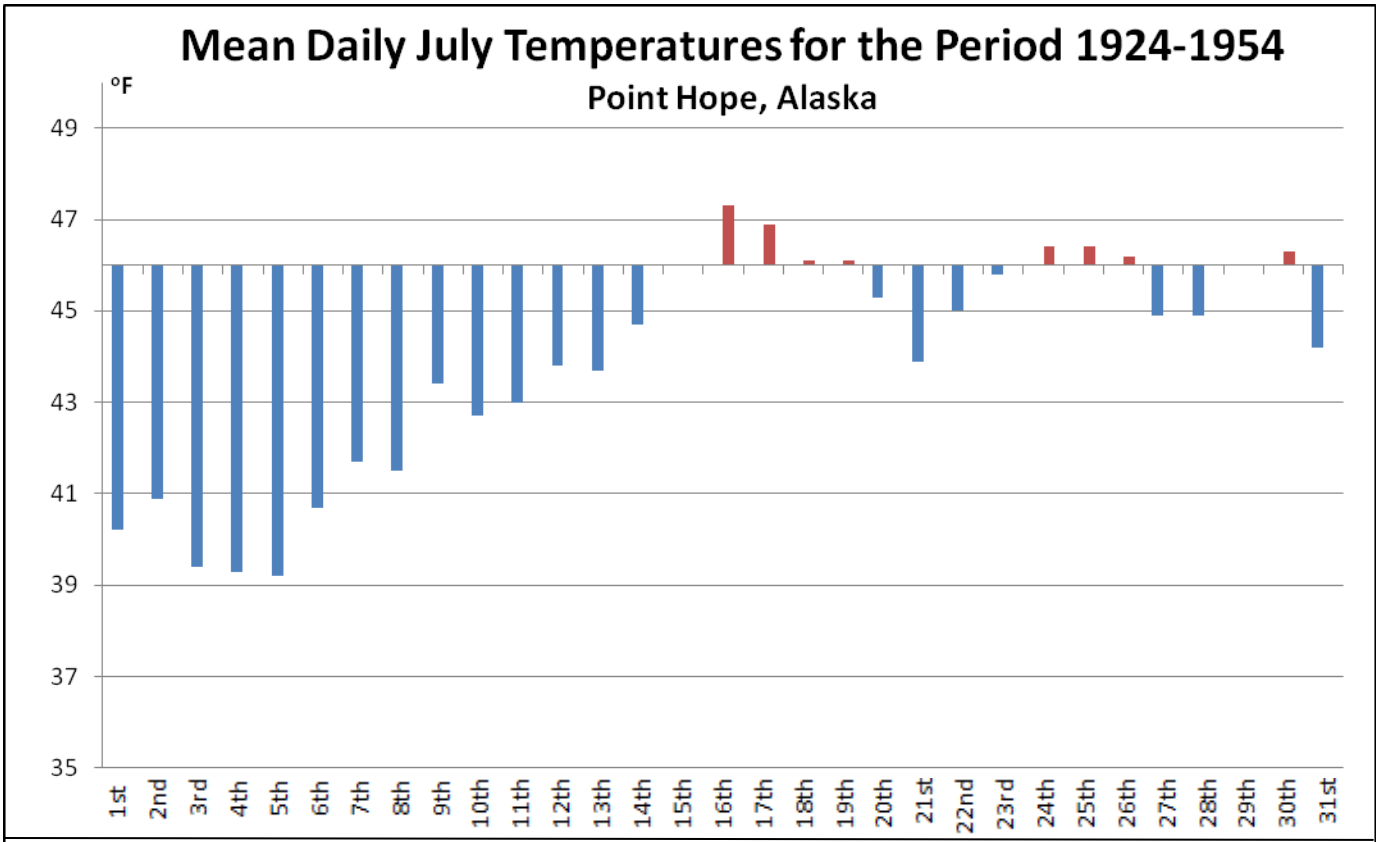
Fig.4 Source: *National Weather Service*

The Center for Climate and Health reviewed available climate data for Point Hope to compare historical and current trends in air temperatures. No lake water temperature data was available. Although there is limited data for Point Hope, wind and temperature records are available from 1924 to 1954. Figure 4 below shows historical data on the number of July days above and below the 46°F mosquito development threshold.

For this period, temperatures did not exceed the mosquito threshold until the middle of July; mean temperatures were not exceeding 48°F. Figure 5 below provides mean July temperature from the next available time period, 1991 through 2008. Again 46°F, is used as the threshold for mosquito development. Here warming is occurring earlier than in Figure 4, and the temperatures are on average higher, by about 1°F.

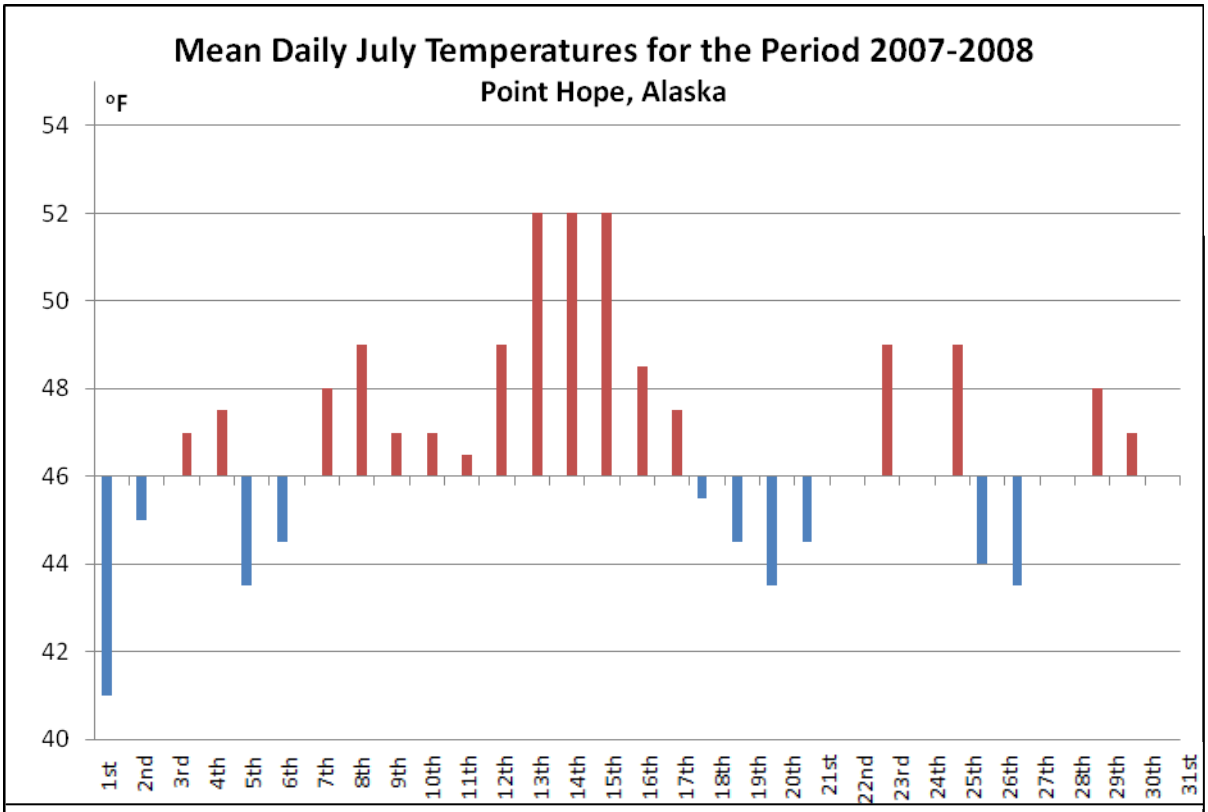
Fig. 6 Source: *Weather Underground*

Figure 6 below shows July temperature data for 2007 and 2008. The mean daily temperatures begin to exceed the 46°F threshold earlier, and the mean temperatures are noticeably higher, reaching the 50°F degrees range by the middle of the month. The data shows that the period in which mosquitoes can survive has been gradually increasing and occurring earlier in the season. July temperatures were extreme during the past two summers. Mosquito larvae usually gather around the perimeter of lakes, where there is more algae growth (Sorenson, F., 2009).

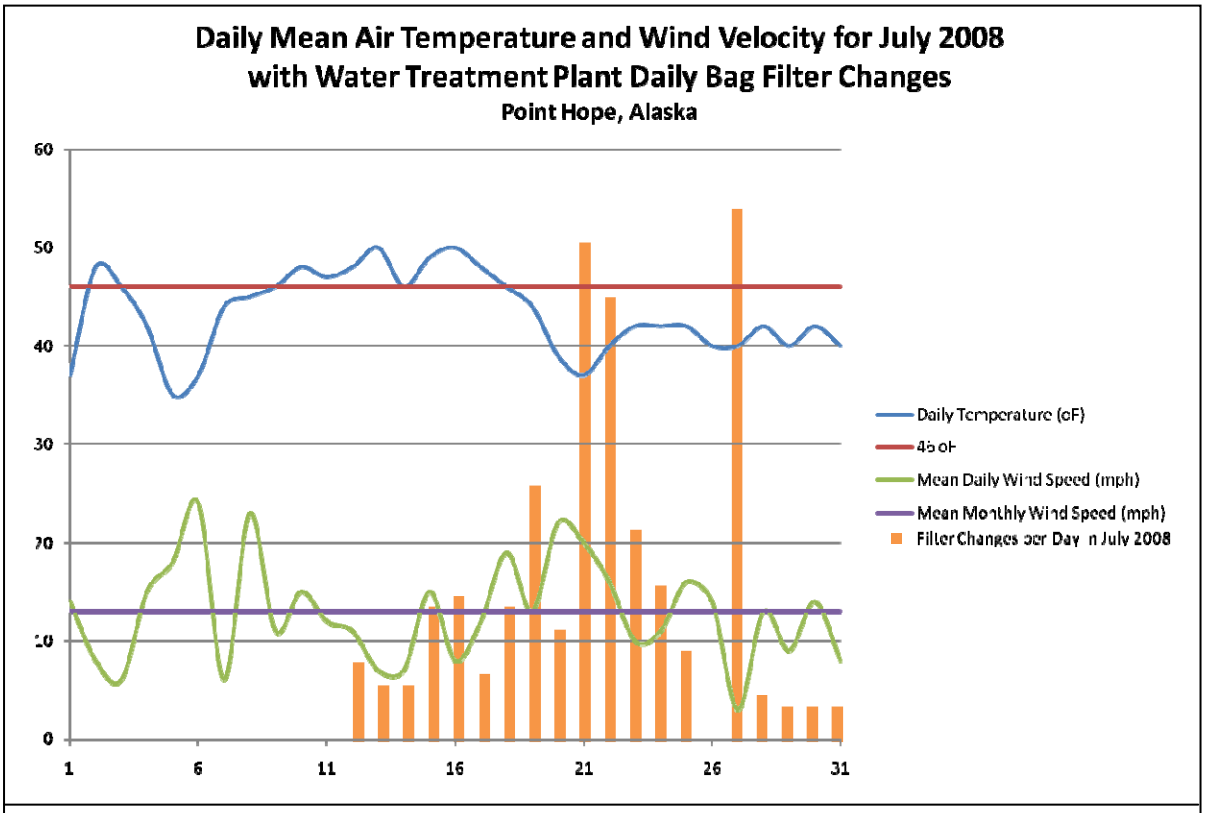
Fig. 7 Source: *Treatment Log Book, Point Hope Water Plant, Weather Underground*

The intake for the water system is located off the lake bank and at a depth of 1.5 feet. Although decreasing water level results in the intake being closer to the bottom and closer to the water's edge, an explanation is needed on how larvae and other organic material are possibly transported to the intake point. As observed by Frankson and his co-operators, many of the biggest filter problems occurred after wind and rain events.

Figure 7 below includes air temperature, wind and bag filter data for July 2008. The blue line shows air temperature increasing until it reaches a sustained temperature above 46°F (red line) on about the 9th of July. The temperature then drops as the wind (green line) picks up around the 19th and continues to build and then decrease through the 25th. The number of filter changes (orange bars) increase with wind, after a sustained warm period. There appears to be a strong correlation between wind velocity and number of filter changes. This suggests that there are at least two factors influencing source water quality: temperature that encourages biologic growth, and wind that mixes the lake and transports the material to the drinking water system intake.

A variety of adaptive responses are possible. These responses apply engineering or ecological approaches and focus on either improving the source water quality, or adapting water treatment procedures or equipment. Engineering responses may include modification of treatment procedures based on weather or water quality conditions or improved filtration. Pre-filters are already in place at the intake and operators are experimenting with use of different mesh size bag filters and placement of the intake based on weather and lake conditions.
