Investigative Energy Audit  
For  
Alaska Tribal Cache (ATC) Building

Prepared For  
**Seldovia Village Tribe**

Prepared By  
**Curtis Boudreau, PE, CEM**

**April 3, 2017**

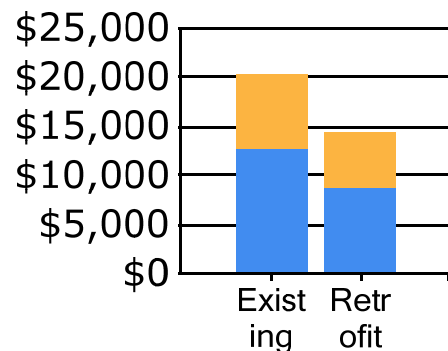
**Annual Energy Costs By Fuel**

Based on unsubsidized electricity and fuel oil prices in effect at the time of the audit, the total predicted energy costs are \$20,280 per year. This includes \$12,873 for electricity and \$7,407 for #1 fuel oil.

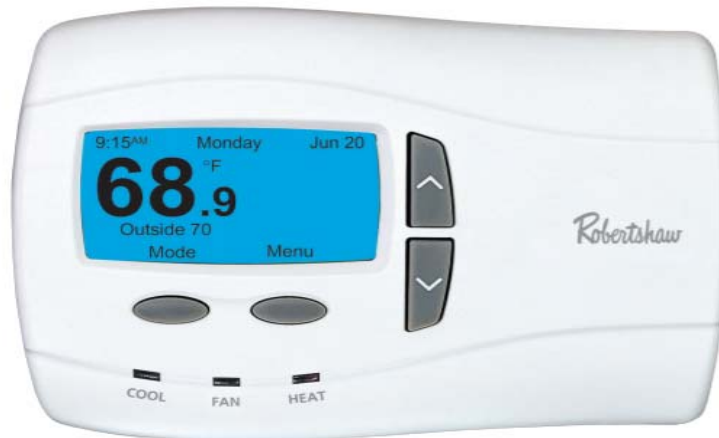
## 9701i2

**Menu Driven Display**  
**7 Day Programmable with 2, 4 or 6 Events Per Day**  
**9701i2 - 1 Heat / 1 Cool**

**Worry-Free Memory Storage**  
Even during power outages, the thermostat maintains set point and programmed parameters.

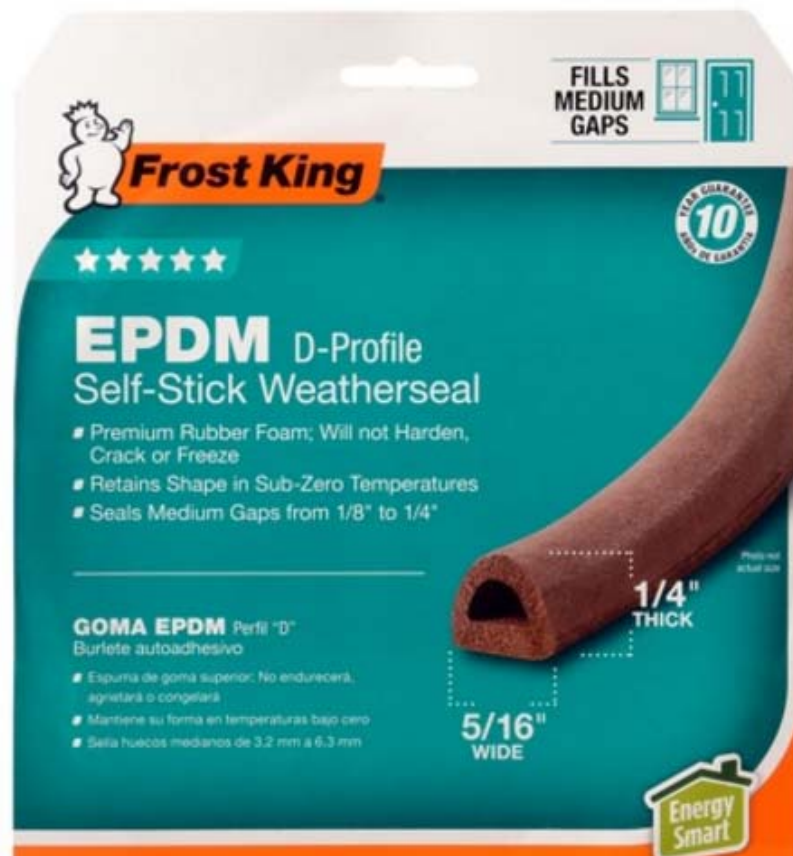
## Attic Access Hatch Weather-Stripping

PRODUCT	SKU	UPC	SPECS	COLOR
<b>D-Section 1/4" Thick - Fits Medium Gaps</b>	V25GA	077578012551	5/16" W, 1/4" T, 17 ft L, D-Section	Grey
	V25BA	077578011776	5/16" W, 1/4" T, 17 ft L, D-Section	Brown
	V25WA	077578011783	5/16" W, 1/4" T, 17 ft L, D-Section	White
	V25BK	077578059228	5/16" W, 1/4" T, 17 ft L, D-Section	Black
