# Investigative Energy Audit For

# Seldovia Village Tribe Visitor Center

Prepared By Curtis Boudreau, PE, CEM

April 3, 2017

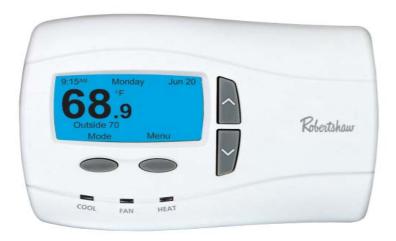
**Menu Driven Display** 7 Day Programmable with 2, 4 or 6 Events Per Day 9701i2 - 1 Heat / 1 Cool

Even during power outages, the thermostat maintains set point and programmed parameters.
